# Corey Bishop Drain *Board of Determination Meeting*

**Board of Determination  
January 30, 2018**

*Ottawa County Water Resources Commissioner*

## **PURPOSE OF ENGINEERING REVIEW:**

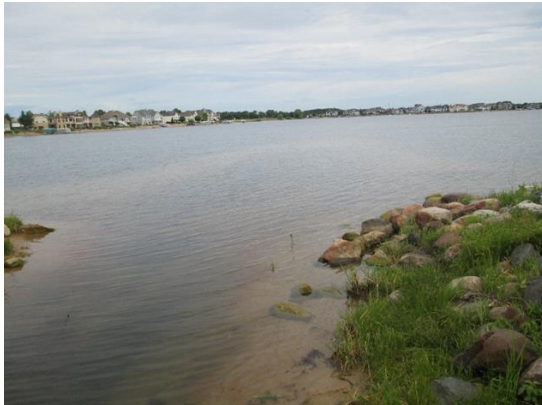
Sedimentation in Georgetown Lake at the outlet of the Corey Bishop Drain (looking north from drain outlet)

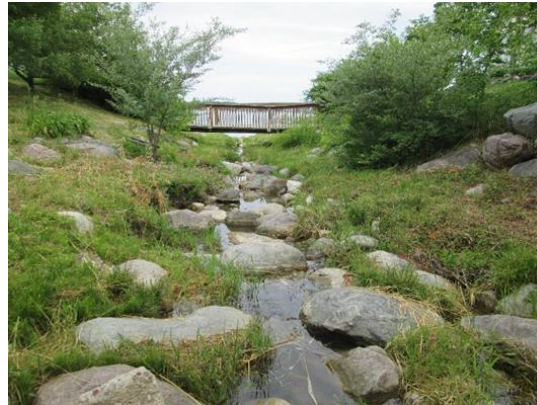
Looking north toward the lake from the Van Buren Street box culvert outlet

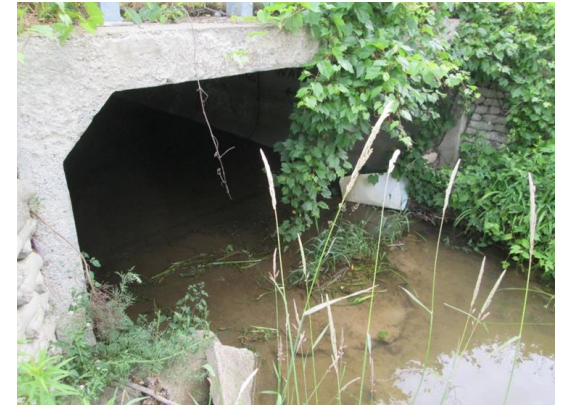
Looking northeast at the inlet to the Van Buren Street 7' x 16' box culvert

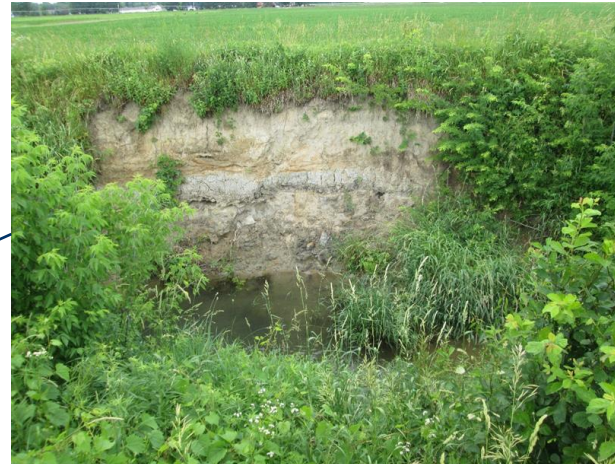
Approximately 25 foot wide section of the west bank eroded into a shear cliff approximately 12 feet tall

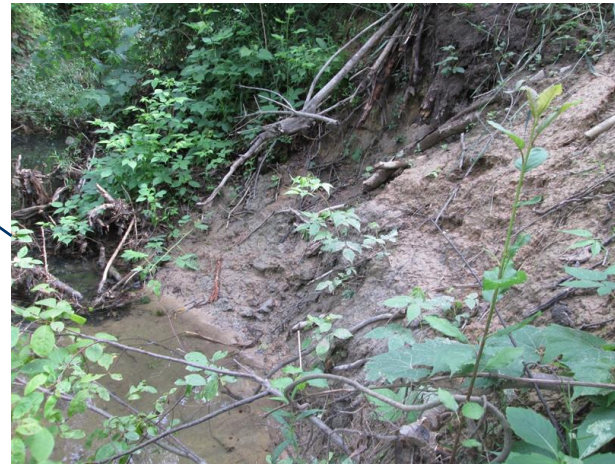
Approximately 12 foot wide section of erosion along the east bank. It should be noted that this type of erosion is nearly continuous for the south 1300' of the drain channel between Barry St. and Van Buren St.

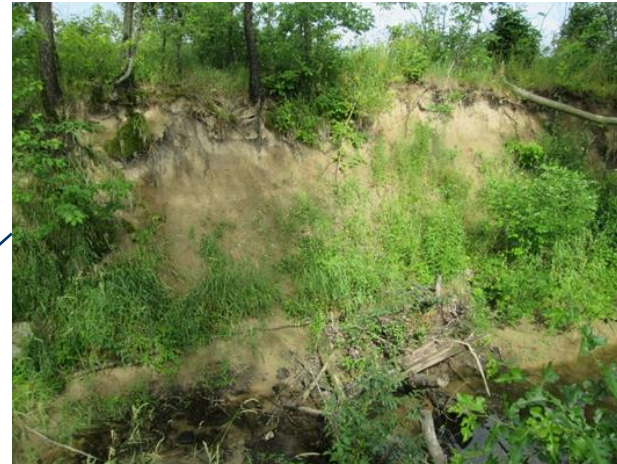
Approximately 60 foot wide section of the west bank eroded into a near cliff approximately 15 feet tall with debris fallen into the drain channel

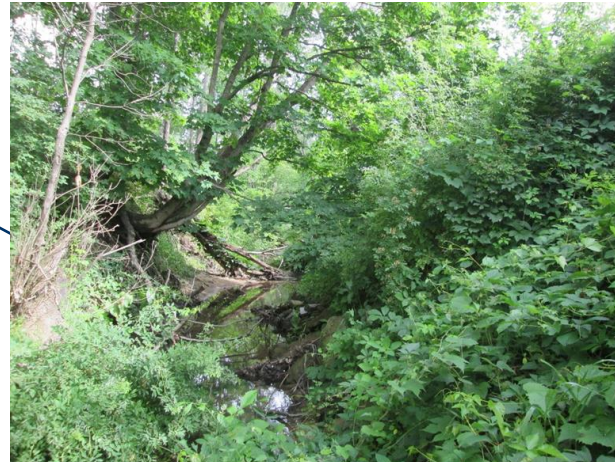
Typical cross section of drain channel looking downstream with erosion on the banks and debris in the drain channel

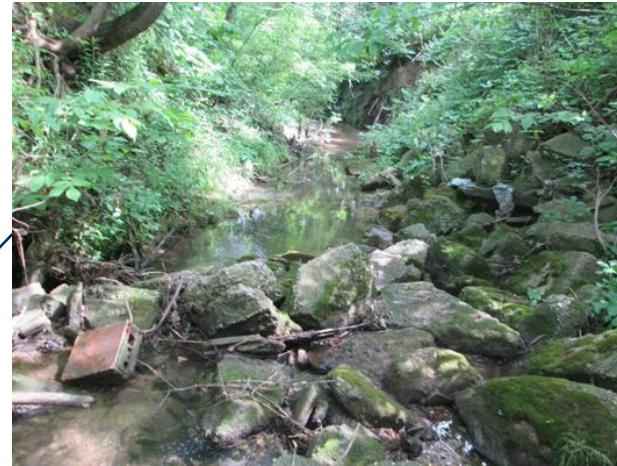
Looking  
downstream at  
large debris piles in  
the drain channel

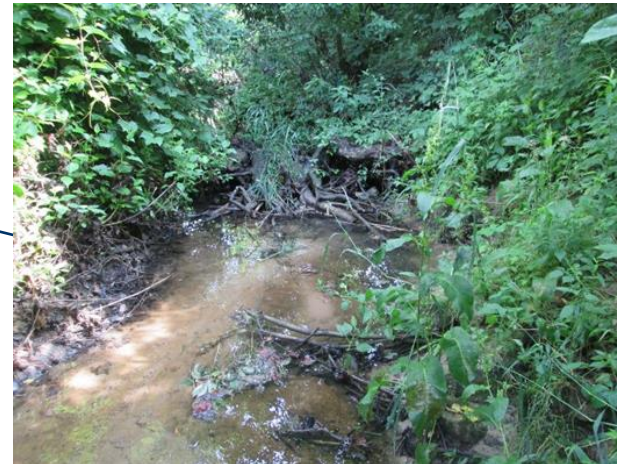
Looking  
downstream at  
large debris piles in  
the drain channel

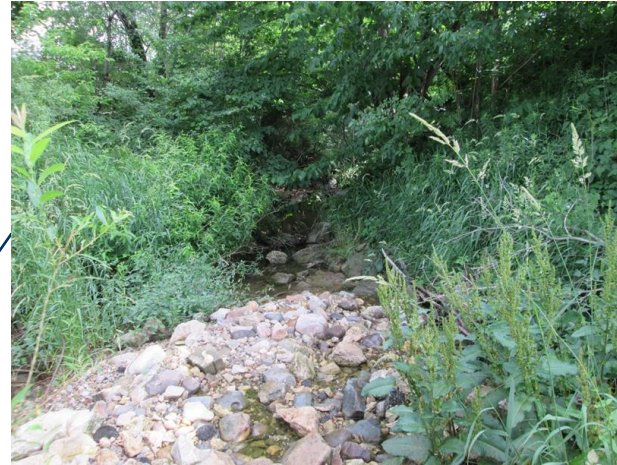
Looking downstream (north) at riprap fallen into the drain channel

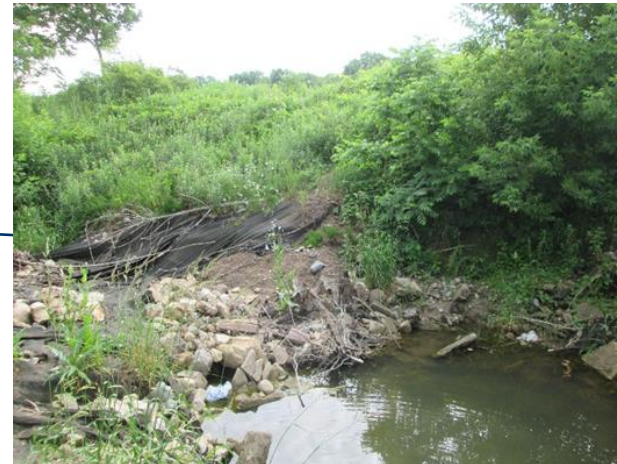
Looking east from the Barry St. culvert outlet with a scour pool shown in the bottom right of photo

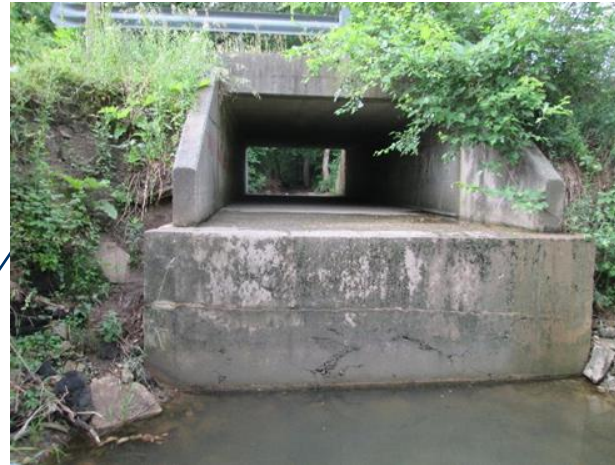
Looking upstream at the Barry Street 6' x 12.5' box culvert with a large scour pool at the bottom of the photo

The first issue which should be addressed is the washout and erosion immediately downstream of the Barry Street culvert. We recommend that gabions be placed along the culvert and extended downstream to help prevent washout and erosion of the banks.

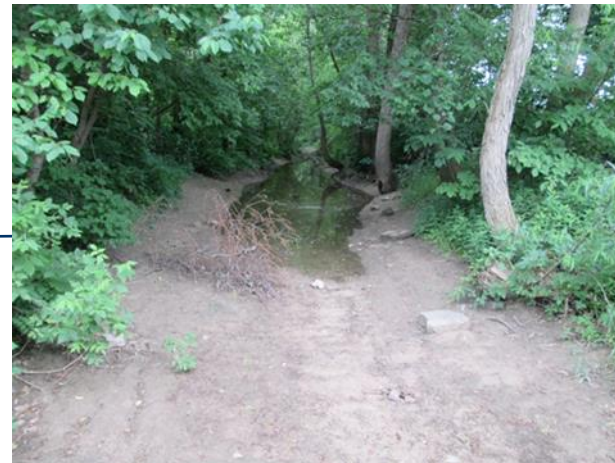
Looking upstream from the inlet to the Barry Street box culvert demonstrating the improperly graded channel south of Barry Street

This is another repair which is seen as essential to restoration of the Corey Bishop Drain. Cleanout and regrading will restore an appropriate drain bottom and drain slopes and should be paired with an erosion control option as well to ensure the problem does not recur.

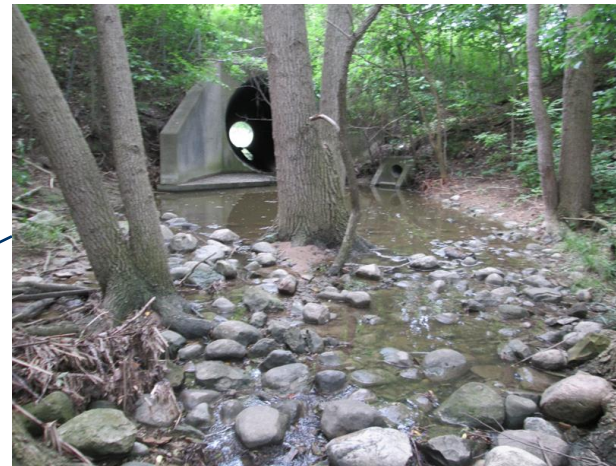
Looking upstream at trees growing in the drain channel just north of the I-196 culvert outlet

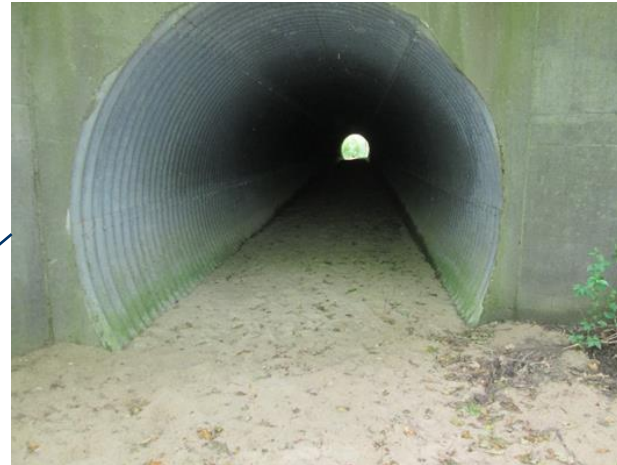
Looking upstream through 11 foot culvert under I-196 with approximately 12-14 inches of accumulated sediment

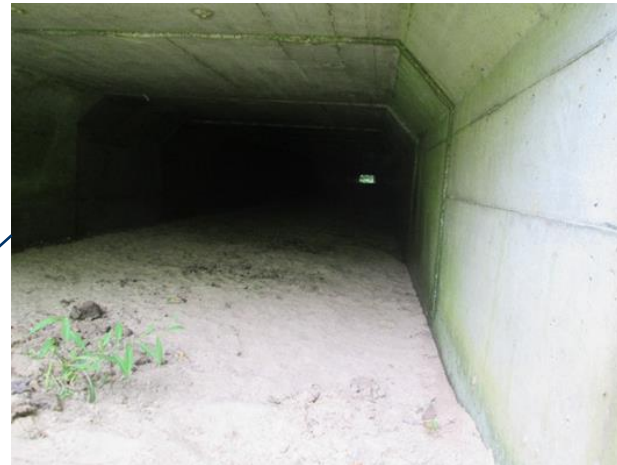
Looking upstream through 10.83 x 7.87 foot box culvert under M-6 with approximately 6-8 inches of accumulated sediment

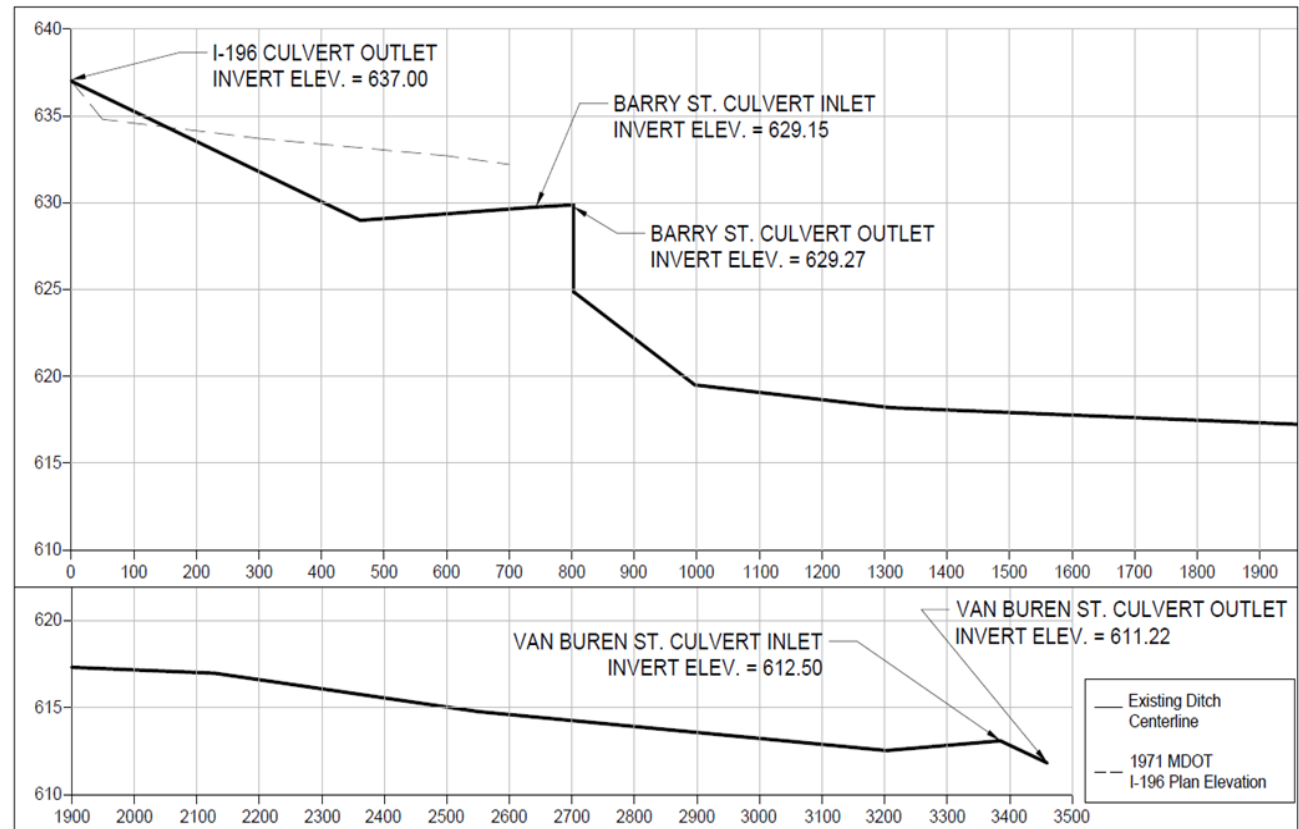
- Large amount of fall over first 1000 feet from the I-196 culvert outlet to just downstream of the Barry Street culvert
- Improper channel grading between I-196 and Barry St. reducing flow capacity by 4000-5000 cfs and leaves the capacity barely above the 10-year 24-hour event flow of 167.13 cfs
- Scour pool directly north of Barry St. box culvert
