# Summerlin North Drain Informational Meeting

# Summerlin North Drain - History

# Summerlin North Drain Engineering Design

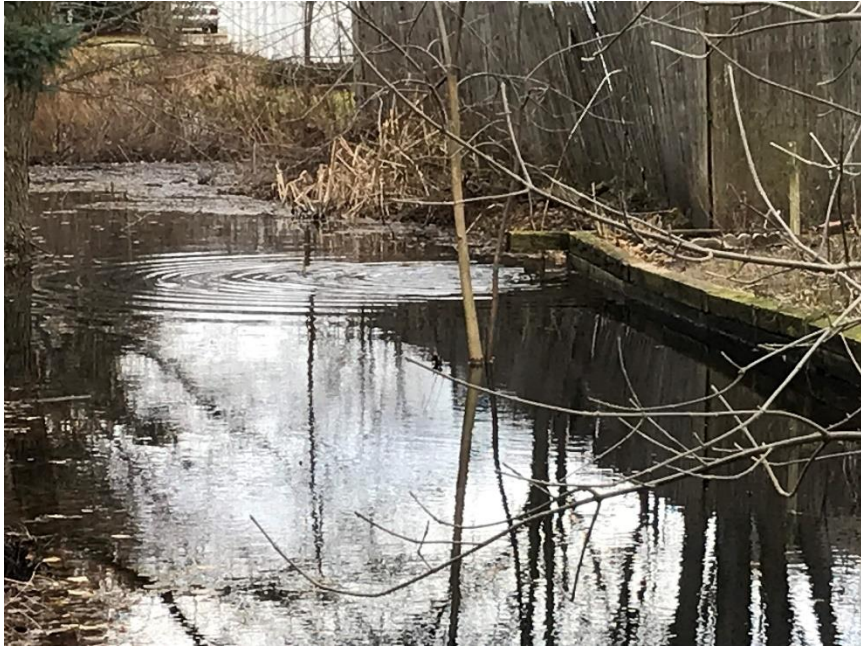
Ponding in Backyard Easement Area – Sump Pumps  
(11/22/19)

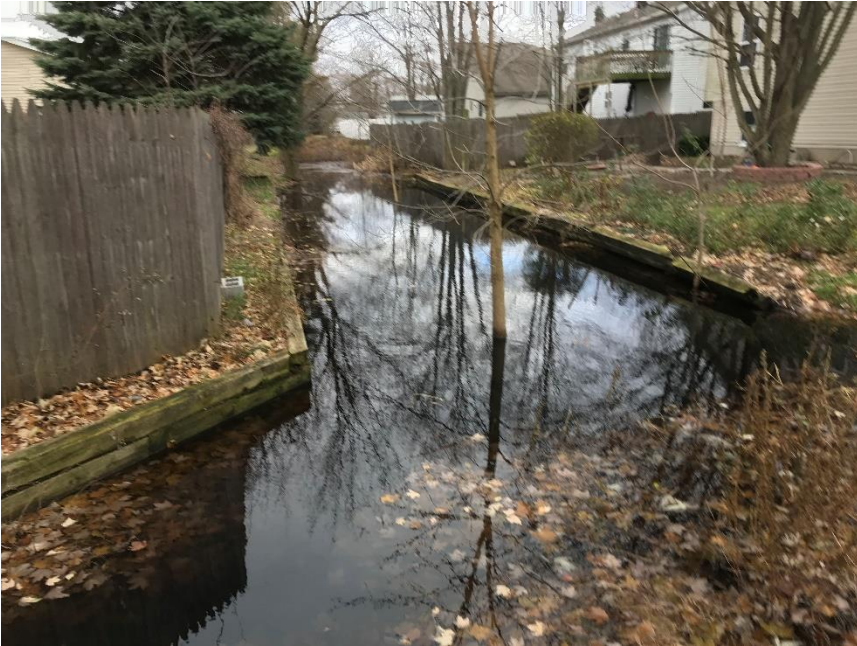
Ponding in Backyard Easement Area (11/22/19)
