Ottawa County's Pigeon River: A Qualified Success Story

Neil W. MacDonald
Biology Department
Grand Valley State University
Allendale, Michigan
October 26, 2009

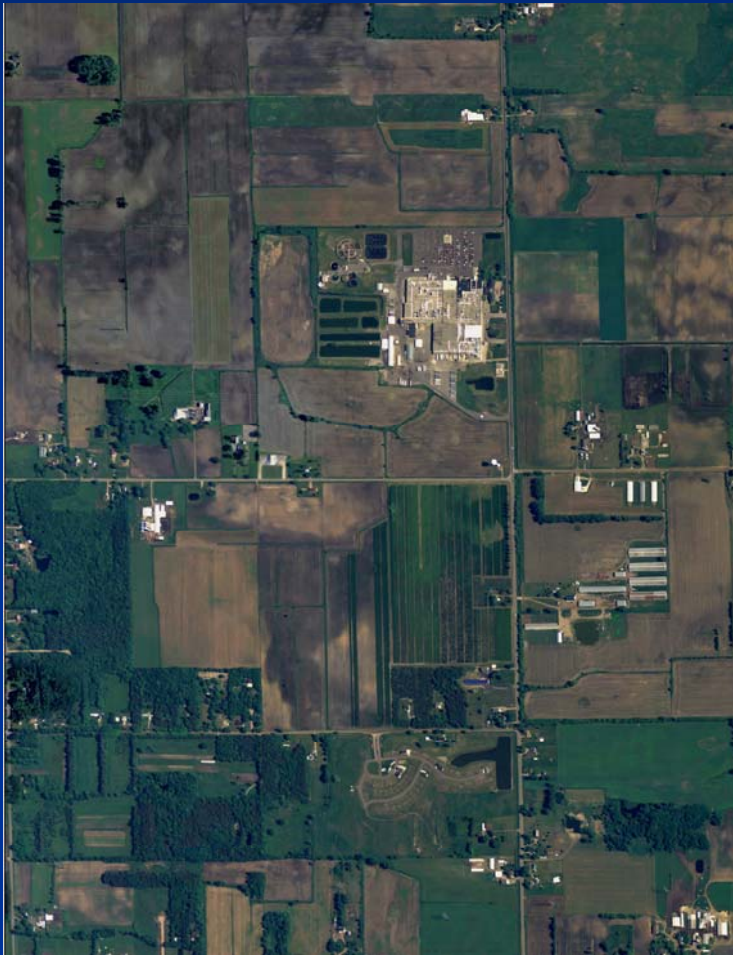
Regulatory Action

- Large food-processing plant in central part of watershed was routinely exceeding permitted discharges of pollutants.
- MDEQ took action in mid 1990s. Company upgraded its water treatment plant and has complied with permitted point-source discharges since then.

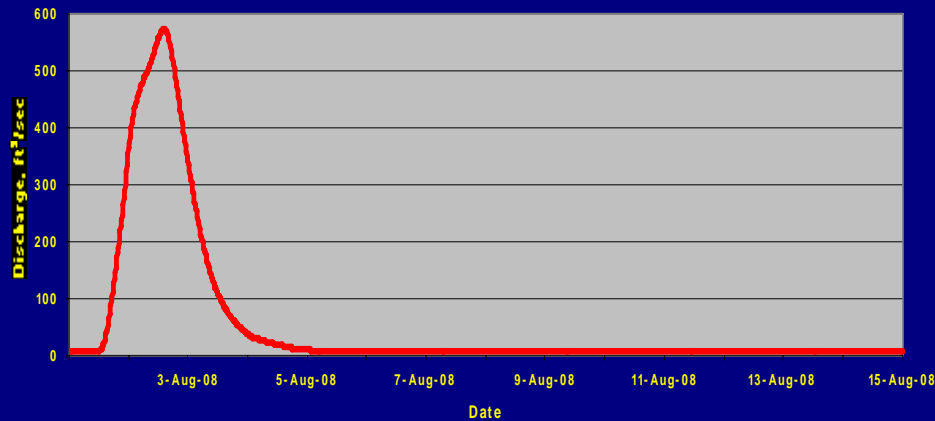
Modeled Discharge at 120th Avenue for 5-Year Storm,
Existing Watershed Conditions

- HEC-HMS Model developed by Dave Fongers of MDEQ to assist watershed planning efforts.

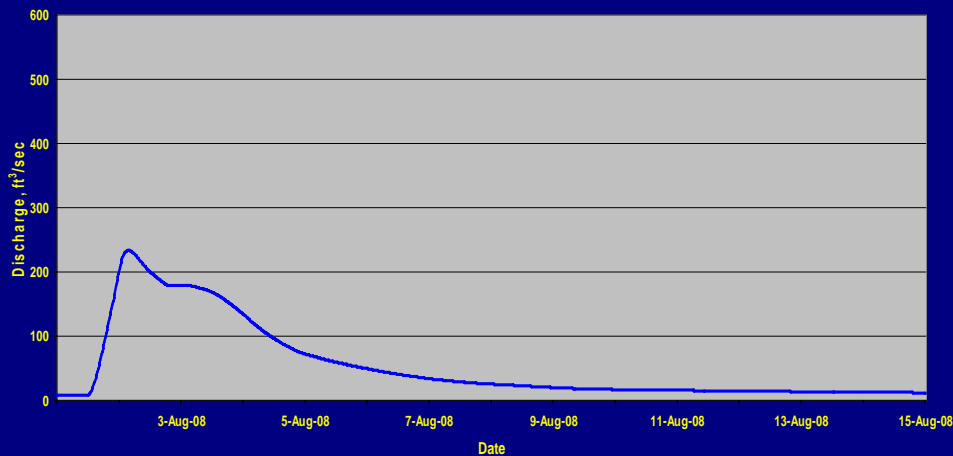
Modeled Discharge at 120th Avenue for 5-Year storm,
Restored Wetlands Upstream

- Model predictions indicate restoration of strategically located areas of upstream wetlands would help regain hydrologic stability.

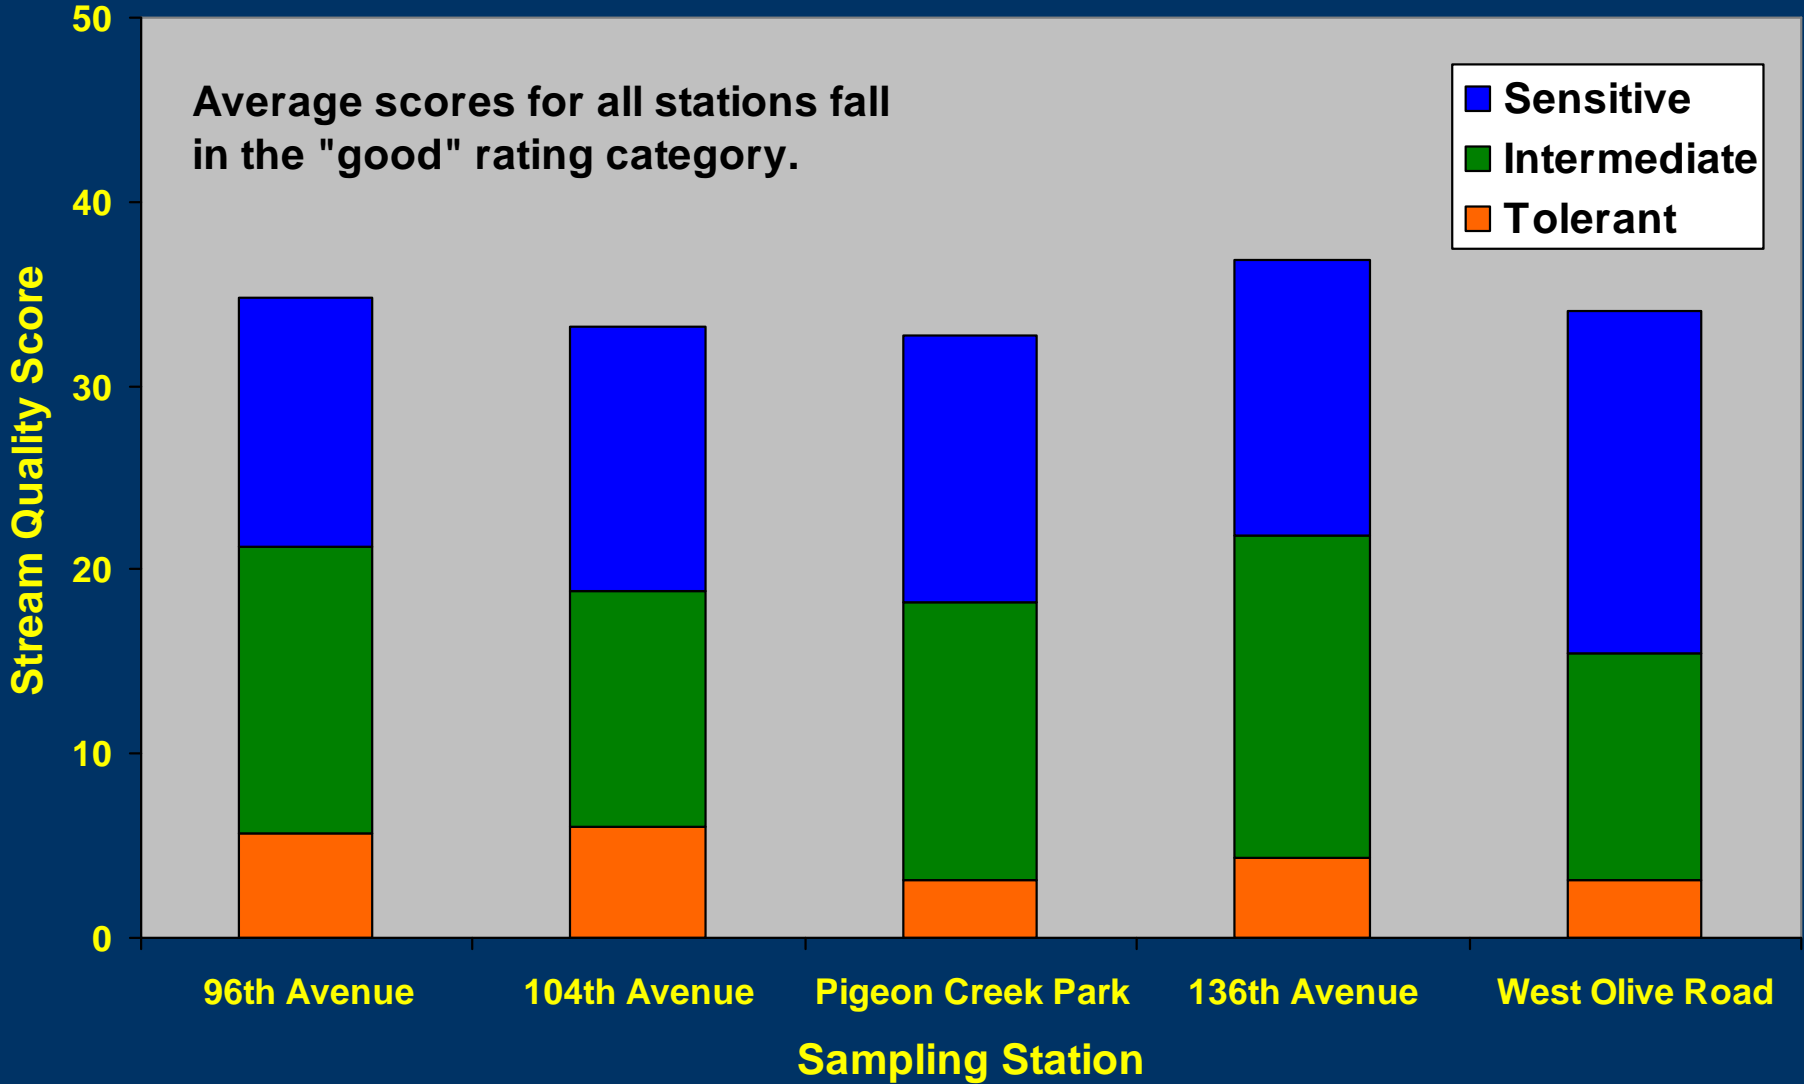
Macroinvertebrate-Based Stream Quality Scores at Five Stations on the Pigeon River, Ottawa County, Michigan, 2005-2008

Average scores for all stations fall in the "good" rating category.

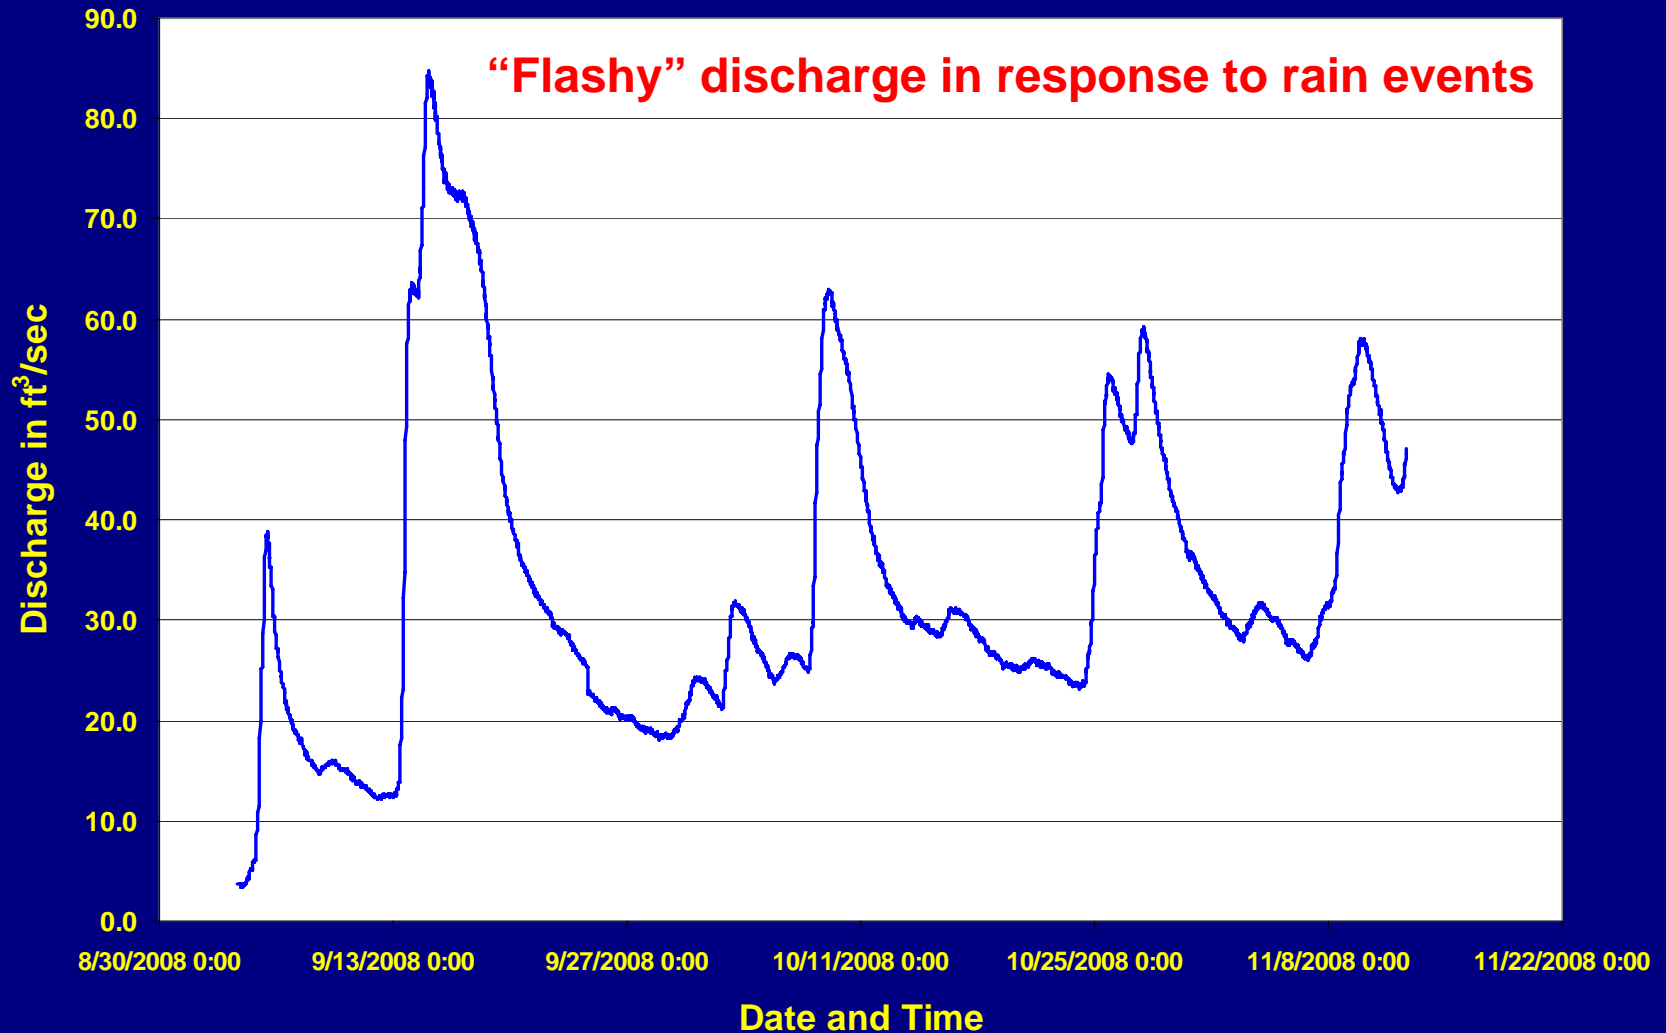
Discharge in the Pigeon River at Pigeon Creek Park, Fall, 2008

Hydrologic Instability

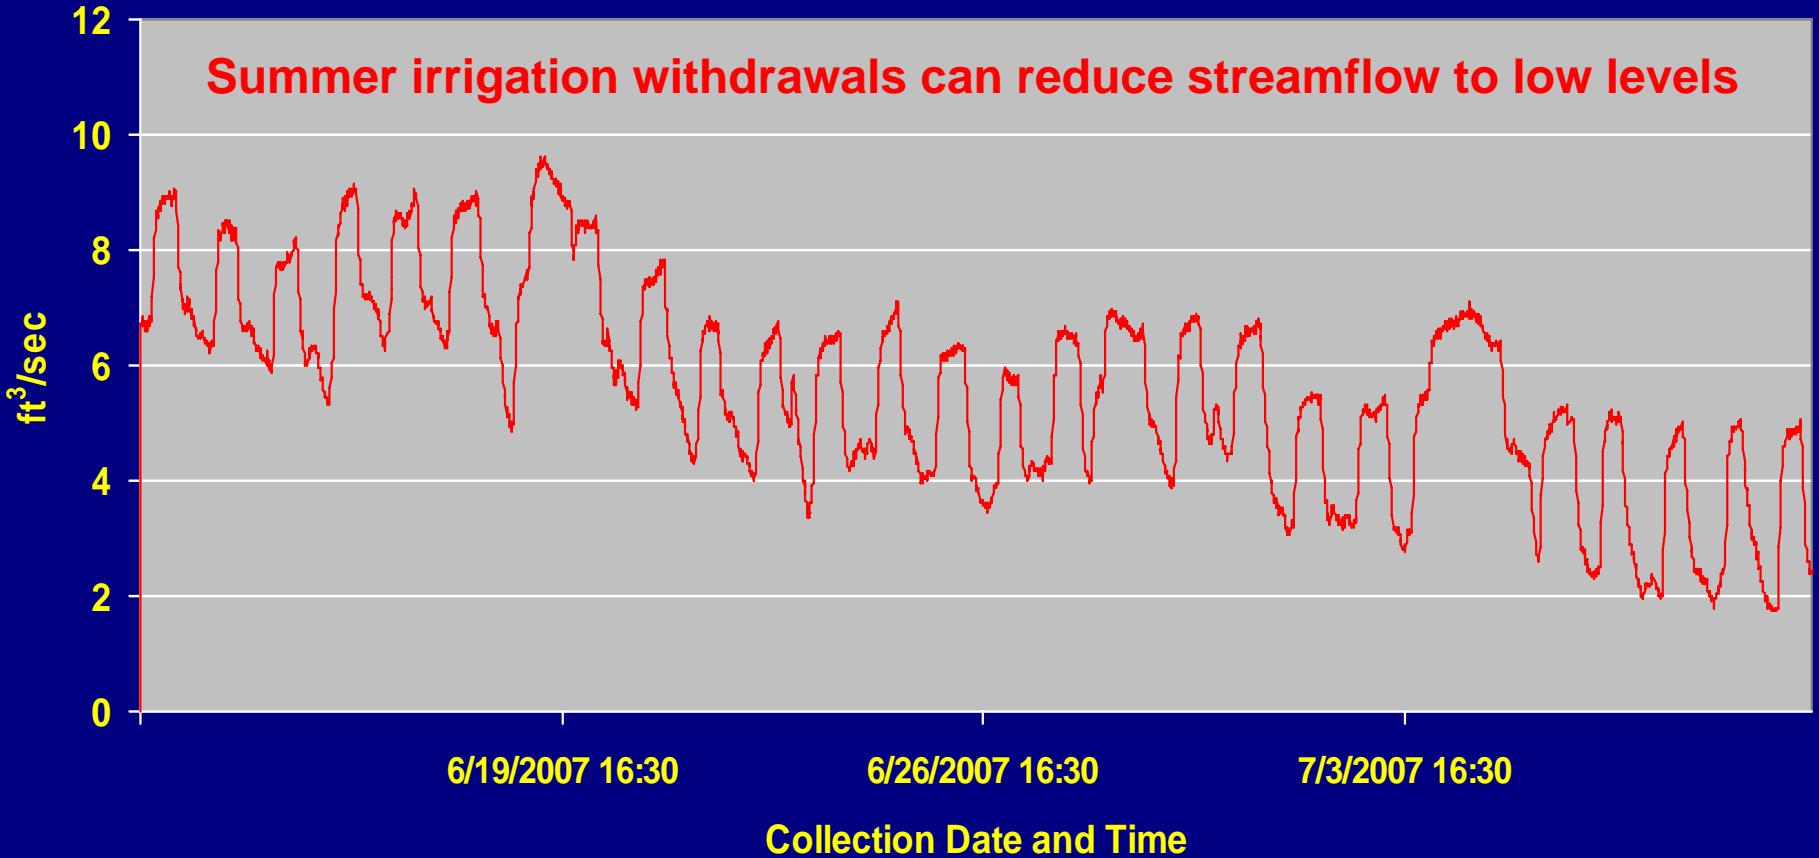
Daily Variation in Discharge in the Pigeon River
Below 136th Avenue, Mid June-Early July, 2007

Irrigation Withdrawals During Low Flows
