#### **PURPOSE OF ENGINEERING REVIEW:**

- Petition from the City of Coopersville for maintenance and improvement to the Drain
- Field review of the Coopersville Community Trails Drain system as well as any proposed branches/extensions
- Identify any potential drainage problems within the Drainage District
- Provide an independent and unbiased assessment of the storm water conditions within the Drainage District
- Summarize all information and report on those findings to a Board of Determination

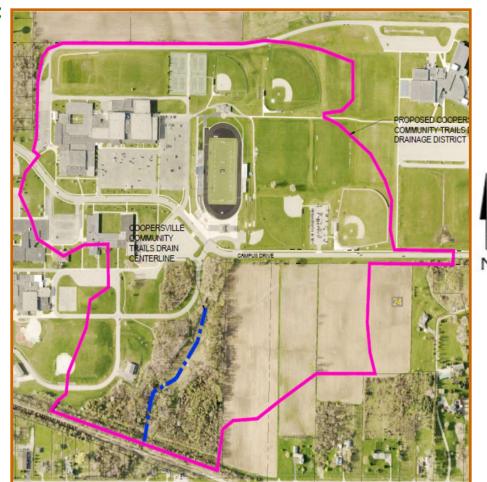
- Heavy sediment and nutrient loading into existing detention pond
- Lack of 'actual' detention due to control structure design
- Grade control / erosion issues
- Coordinated effort between School and Drainage District to fully address issues

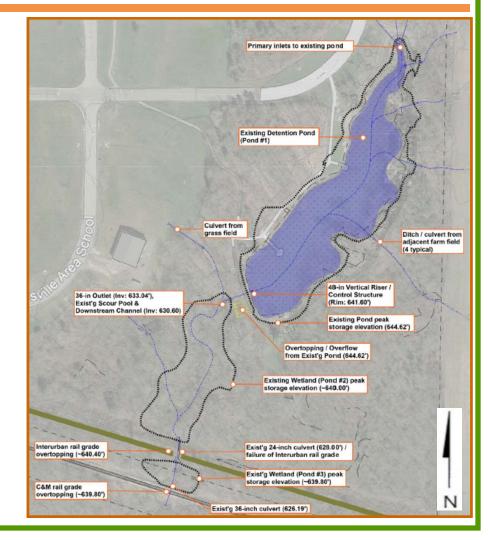
#### **SOIL CONDITIONS**

KnB	Kawkawlin loam, 2 to 6 percent slopes	19.5%
Ма	Made land	32.4%
MmB	Menominee loamy sand, 2 to 6 percent slopes	3.1%
NeB	Perrinton loam, Lake Michigan Lobe, 2 to 6 percent slopes	32.3%

#### **Primary Soil Characteristics:**

- Clay Loam
  - Depth to water table approximately 12-24 inches below grade
  - Runoff Class: High
  - Drainage Class: Poor to Moderate

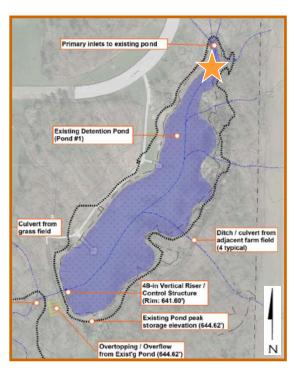
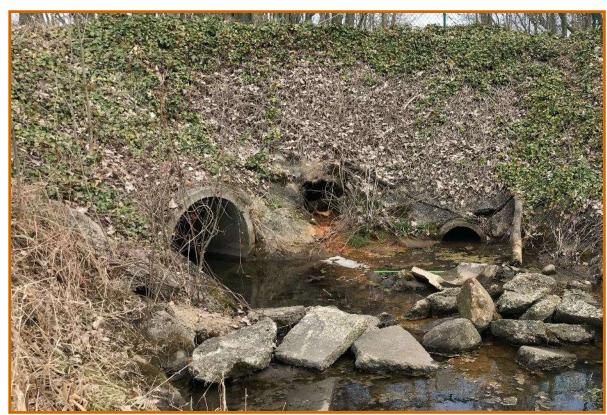
Three (3) main School property discharge pipes at the north end of the pond

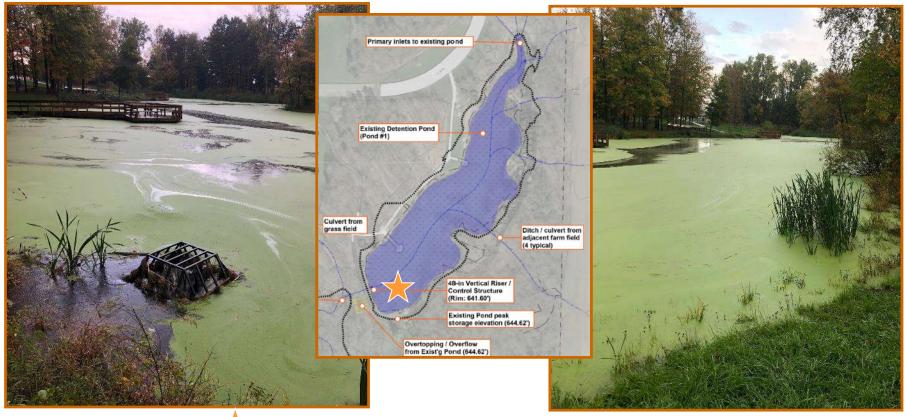
48-inch vertical riser / control structure at south end of pond

Nutrient loading within the pond

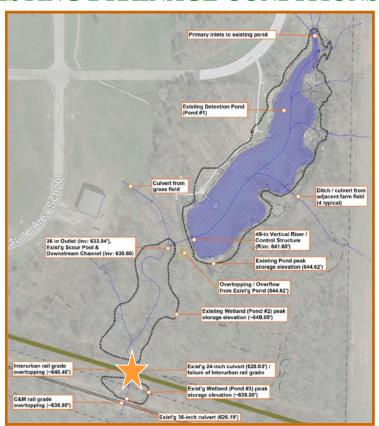
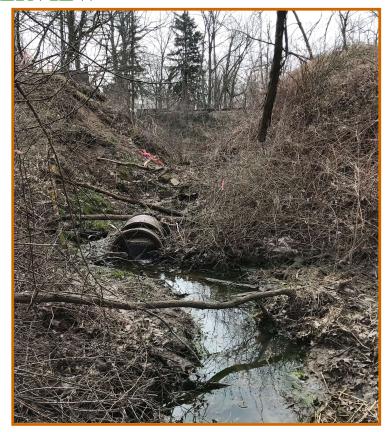
24-inch Railroad bed culvert blowout downstream of pond

\* Recently replaced with 36-inch CSP culvert by Coopersville Schools

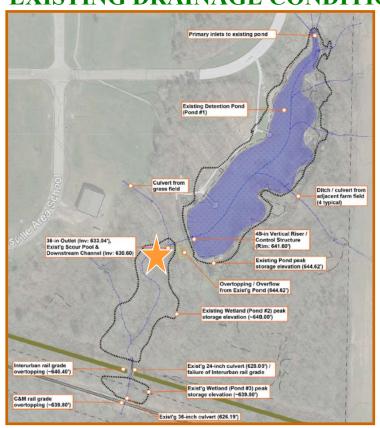
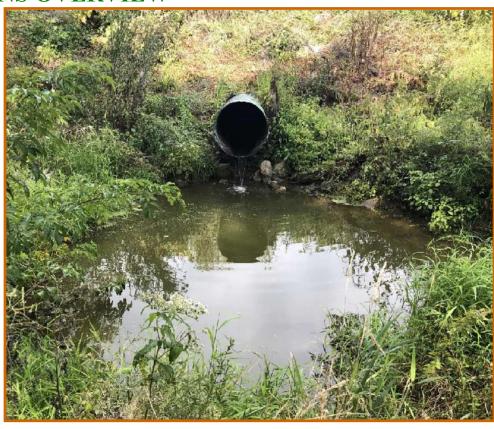
Scour hole at outlet of 36-inch pipe from pond control structure

\* Planned to be addressed with plunge pool by Coopersville Schools
