M-231 and Water Quality

Ottawa County Water Quality Forum
November 21, 2016
James Fortney, MDOT

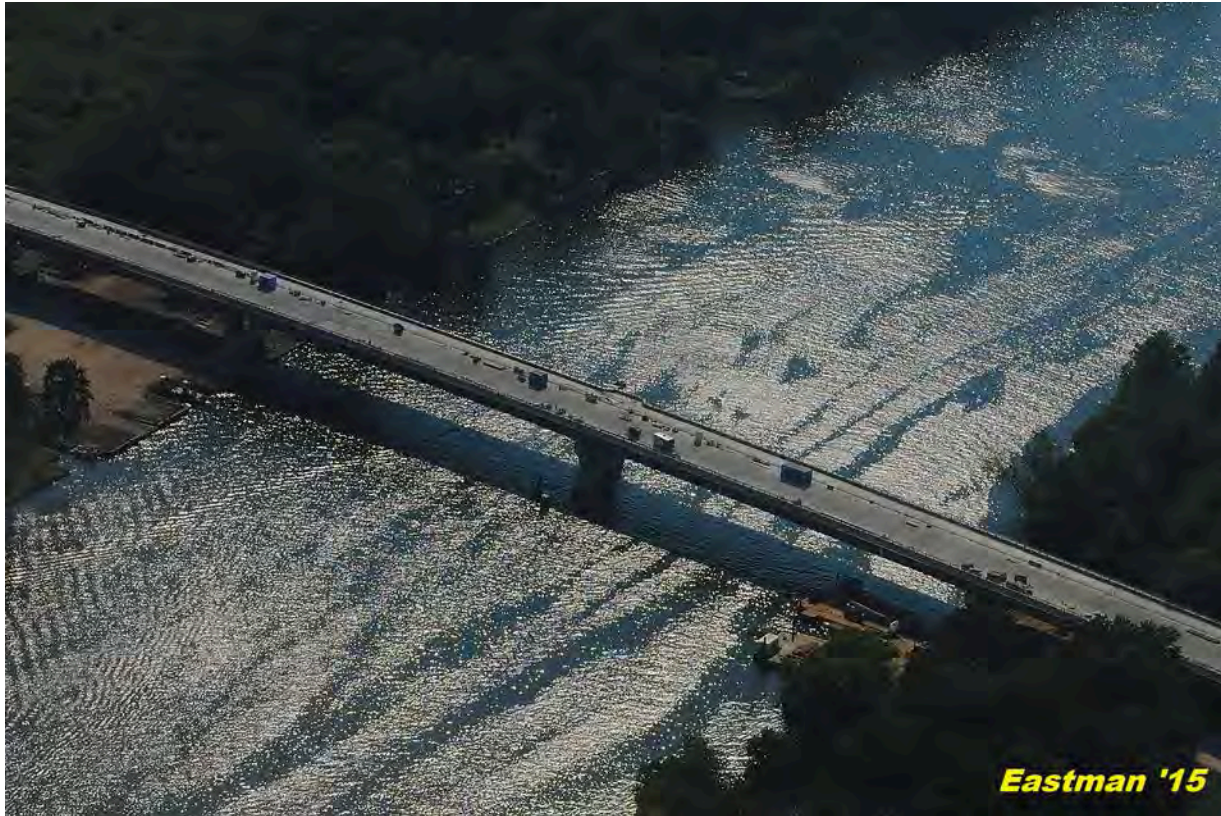
The M-231 crossing of the Grand River is 3,700 feet long

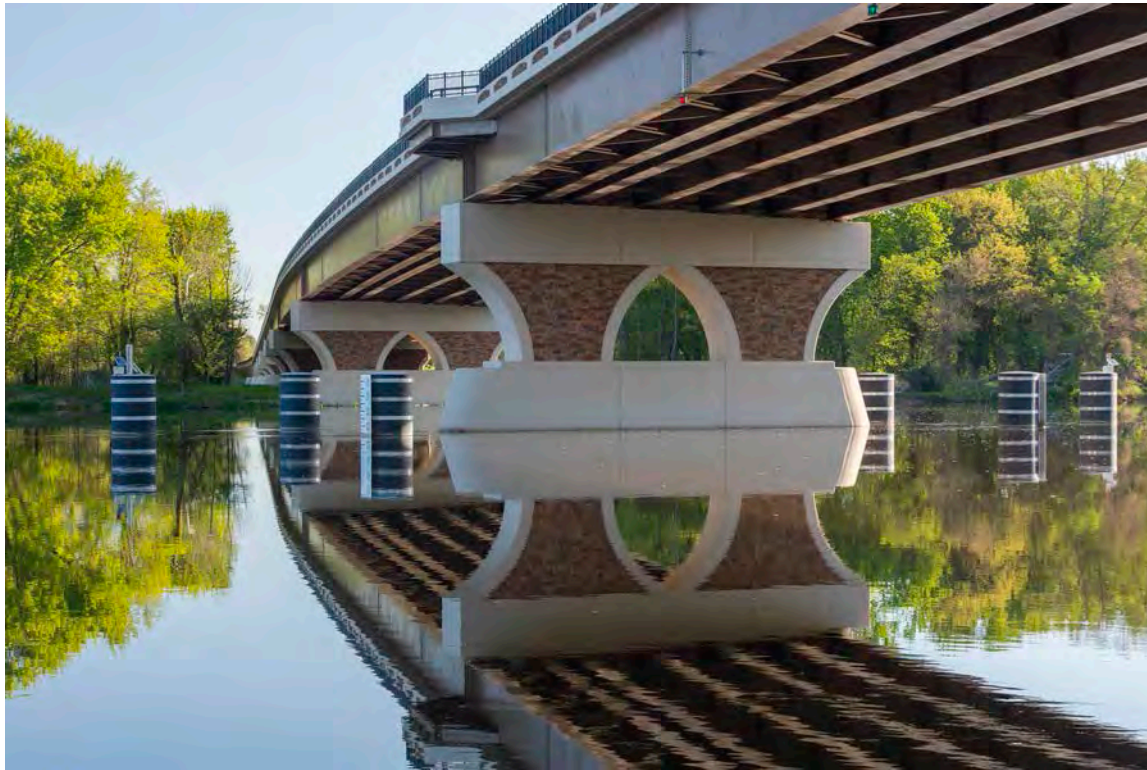
It includes a multi-use lane (MUL) which serves as a non-motorized path

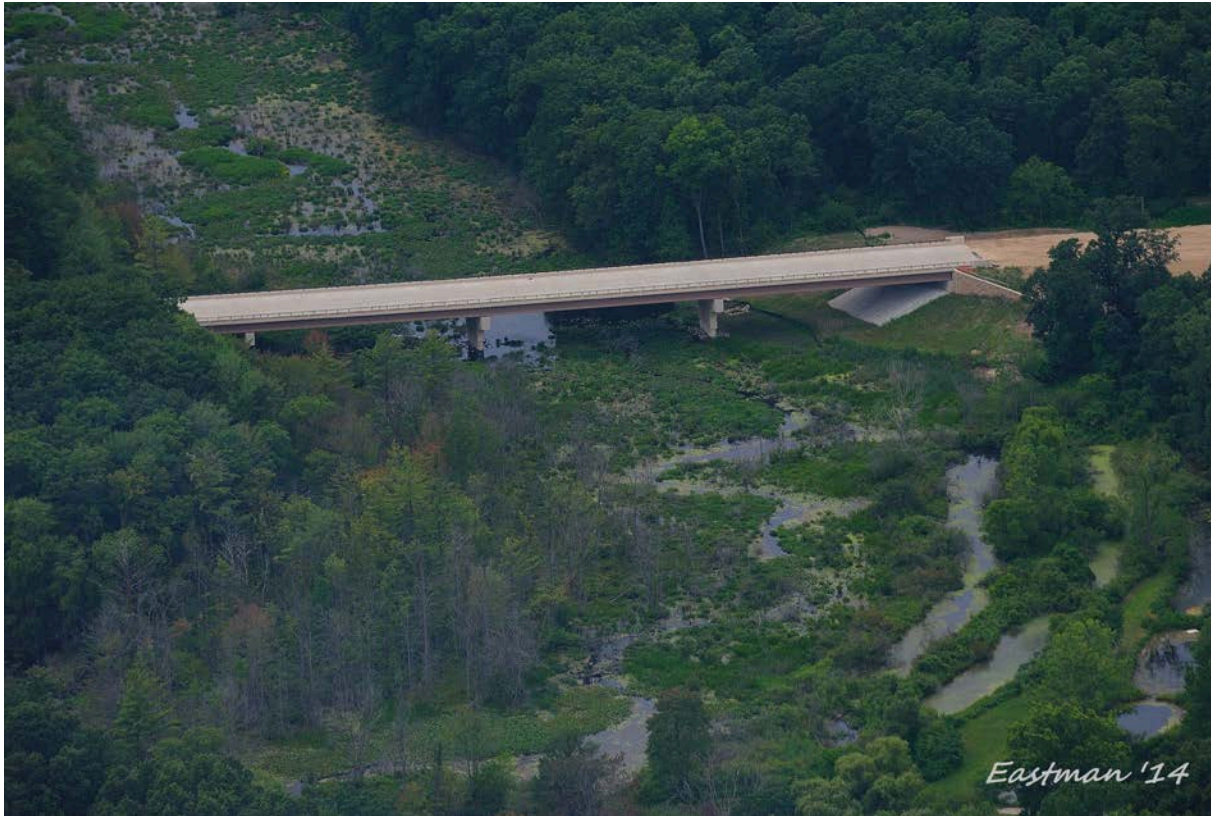
M-231 also includes a 548-foot long bridge over Little Robinson Creek

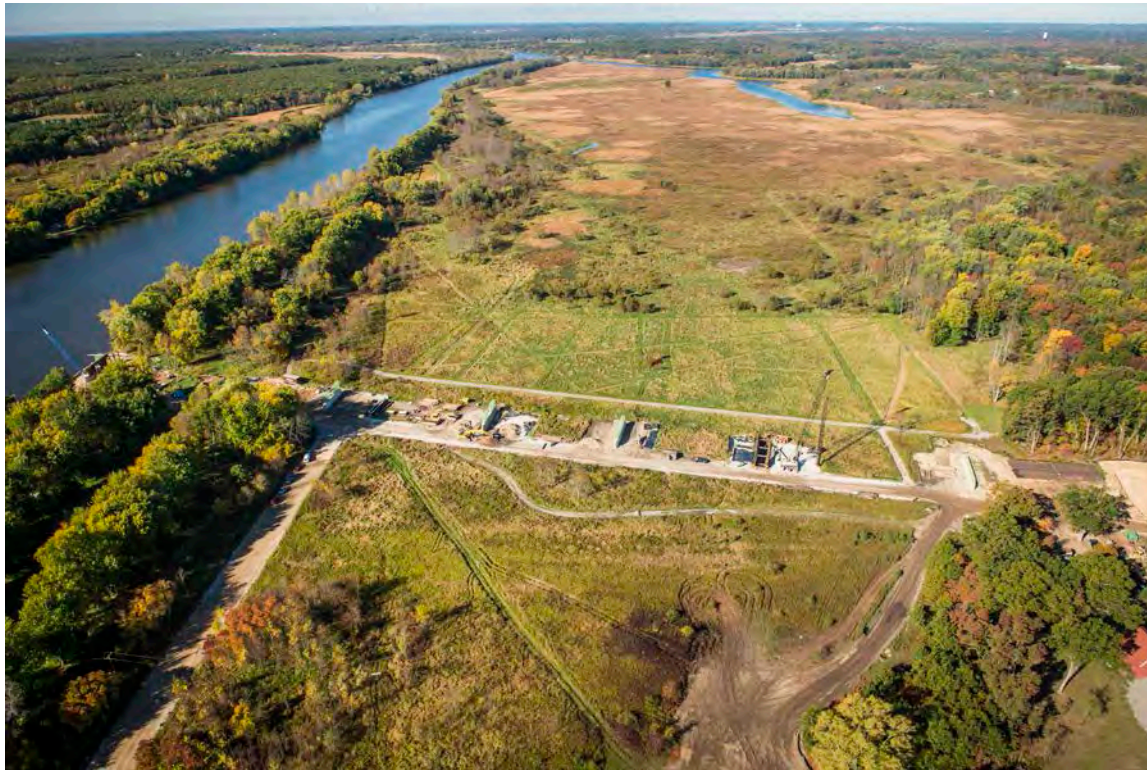
Facing West – M-231 bridge piers in Bruce's Bayou

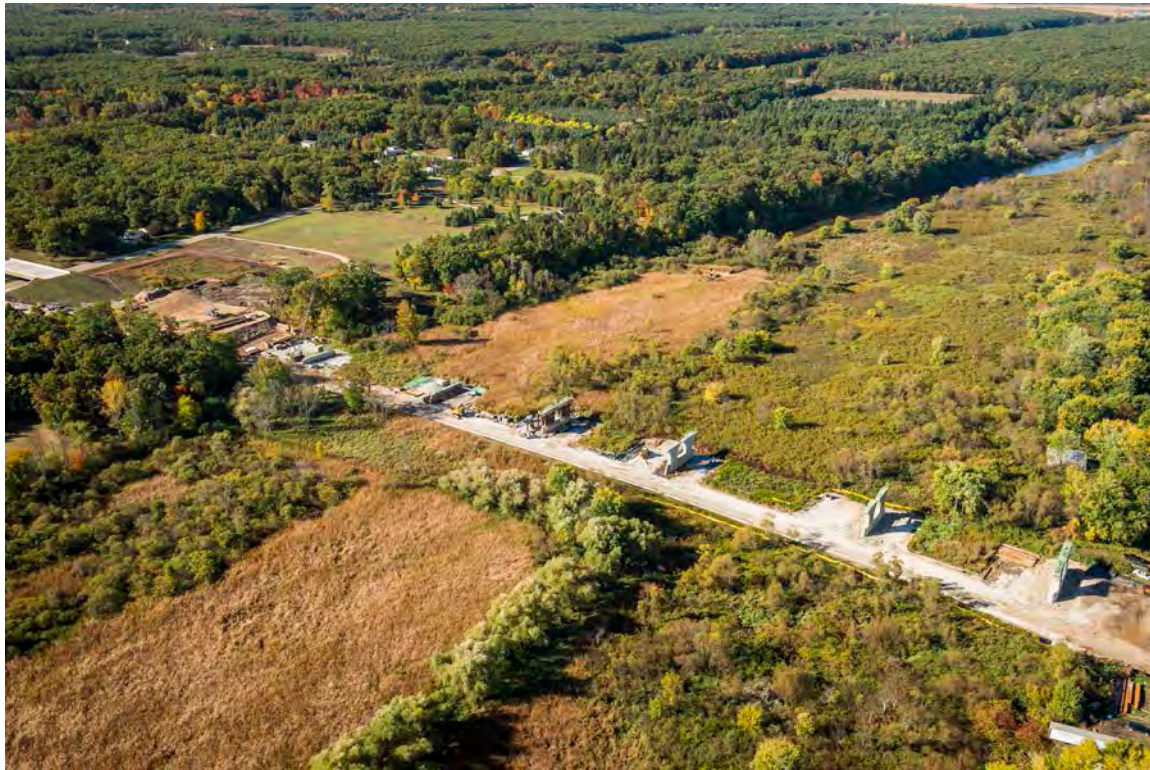
M-231 bridge piers in Conner Bayou on the south side of the Grand River

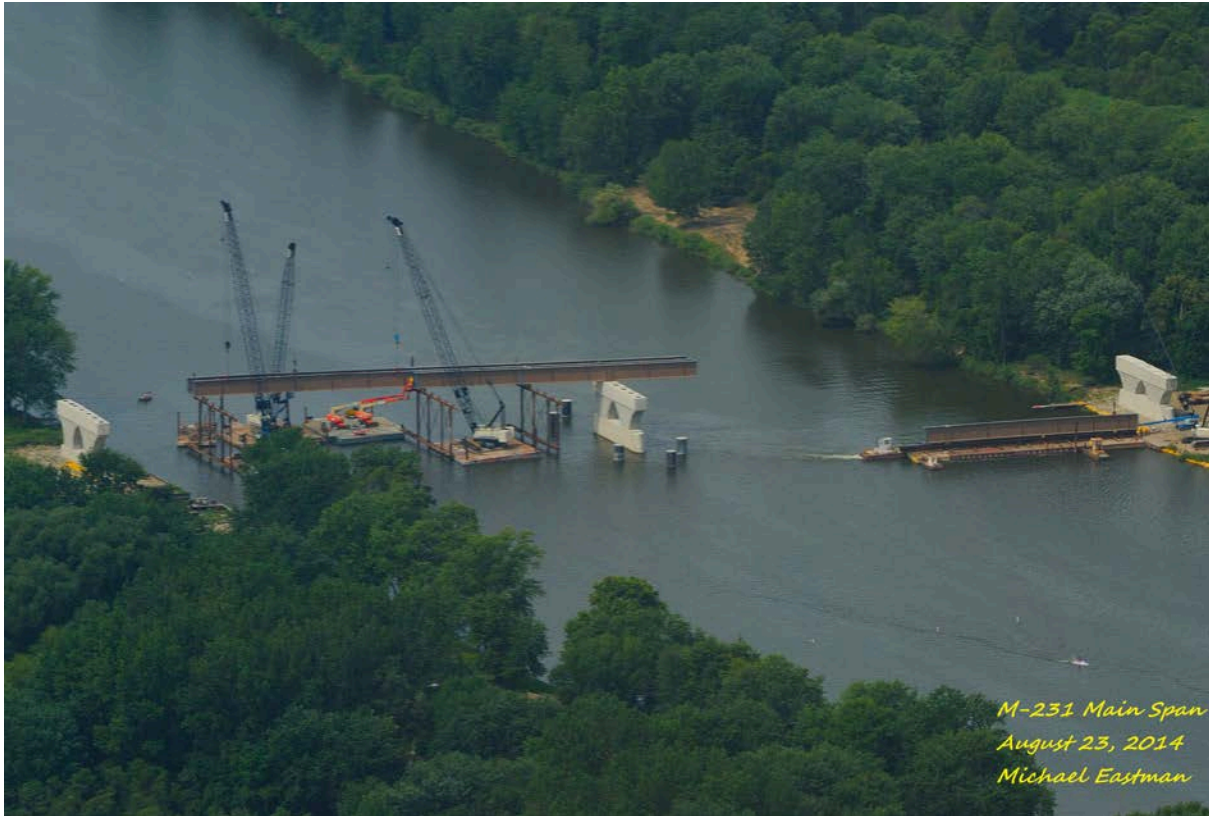
Steel Beam Placement Over the Grand River

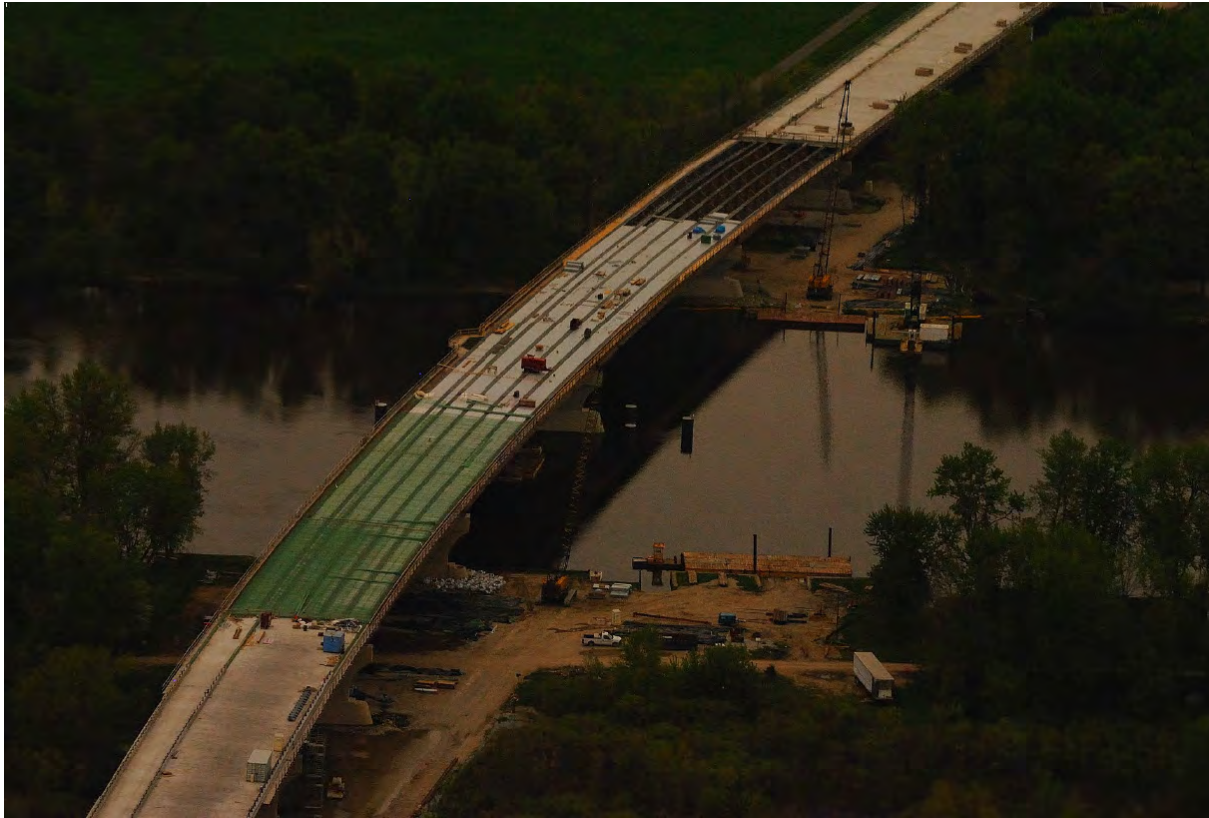
With re-steel and deck pans

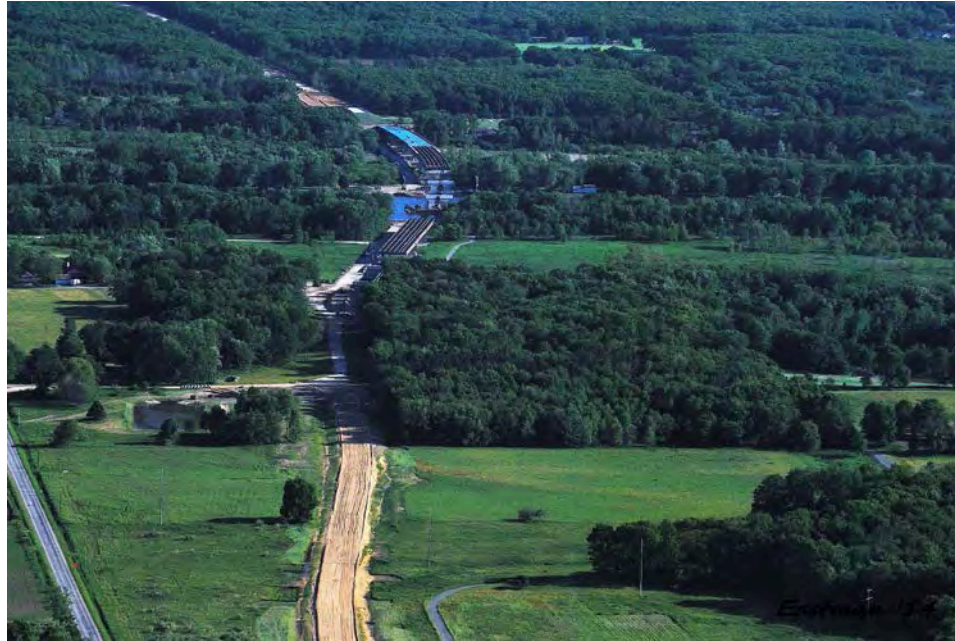
Temporary BMP - Tree clearing was limited to half the right-of-way width through forested areas

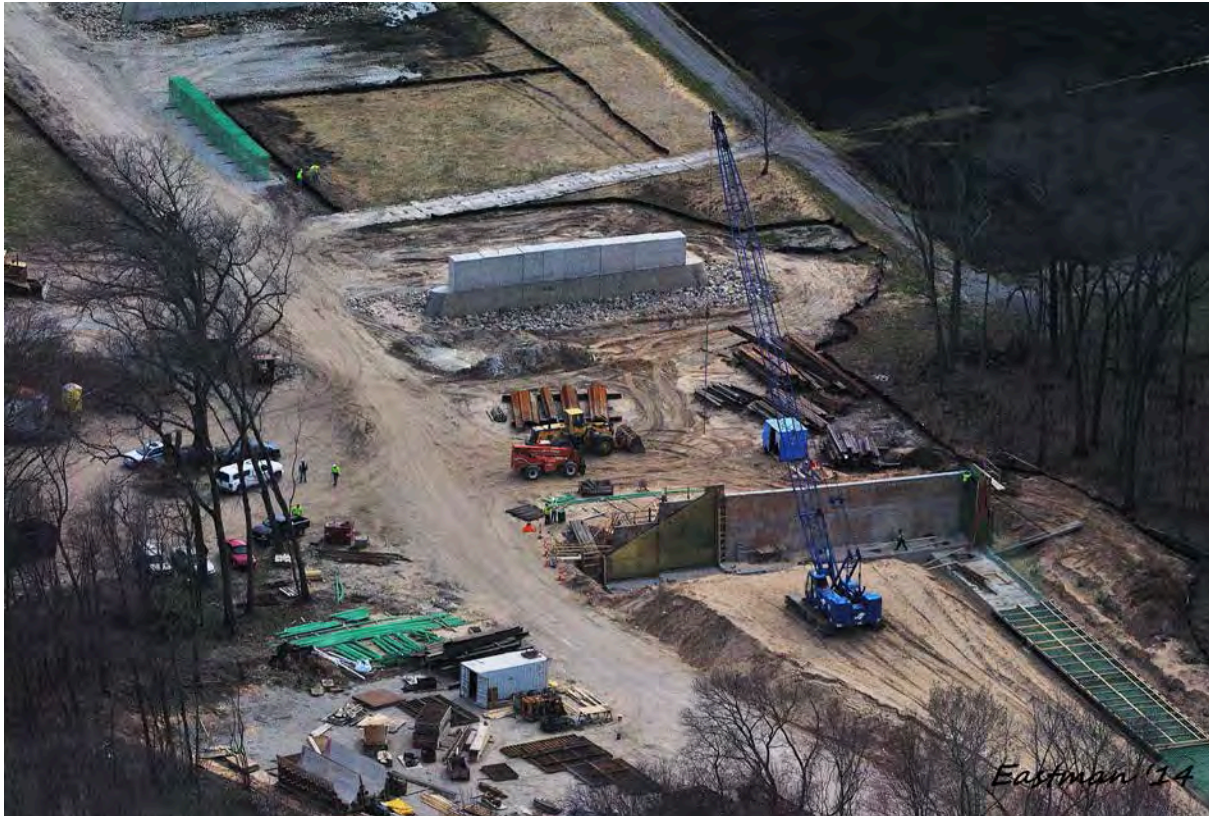
Temporary BMP – Silt fence along the perimeter of all earthwork

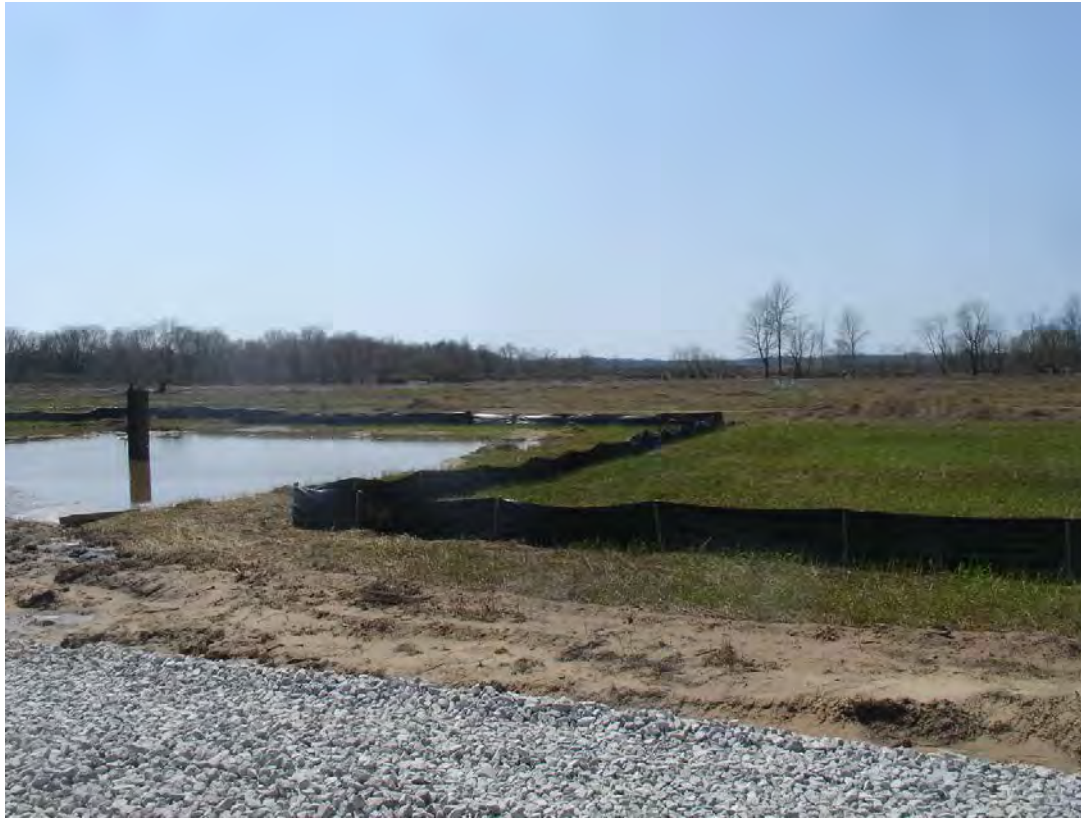
Temporary BMP – Silt Fence along the perimeter of all earthwork

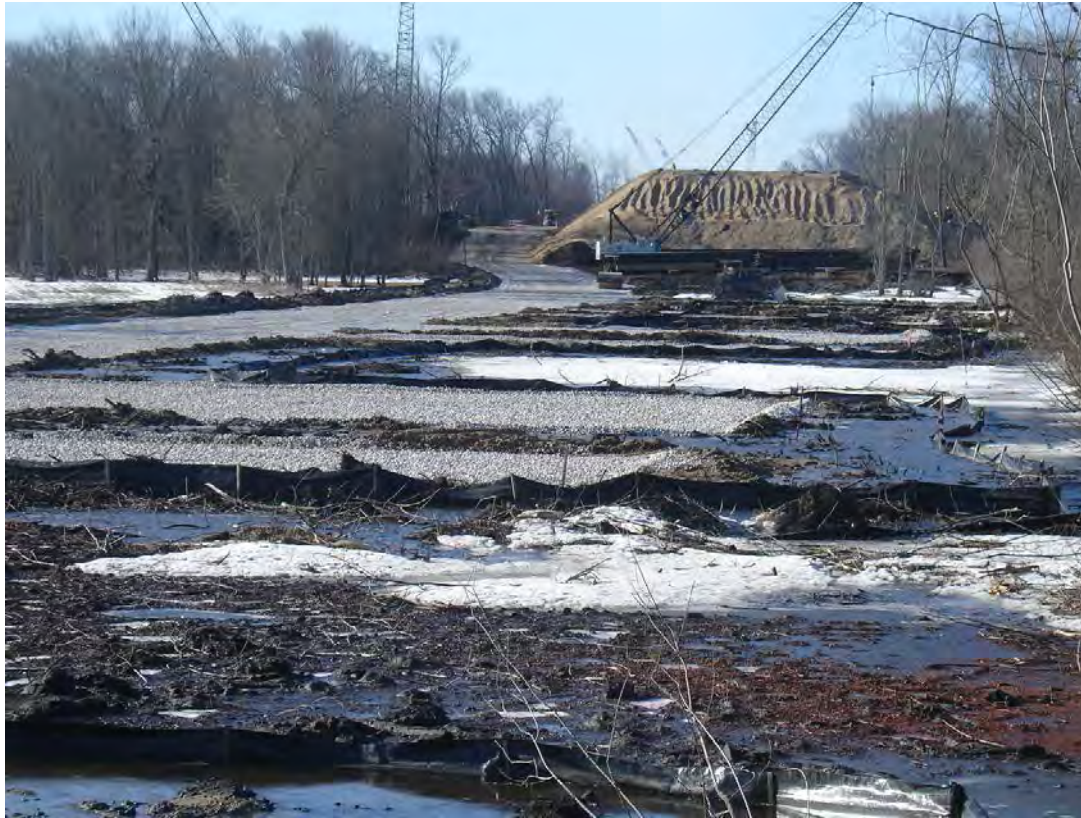
Temporary BMP – Silt fence around each (future) pier

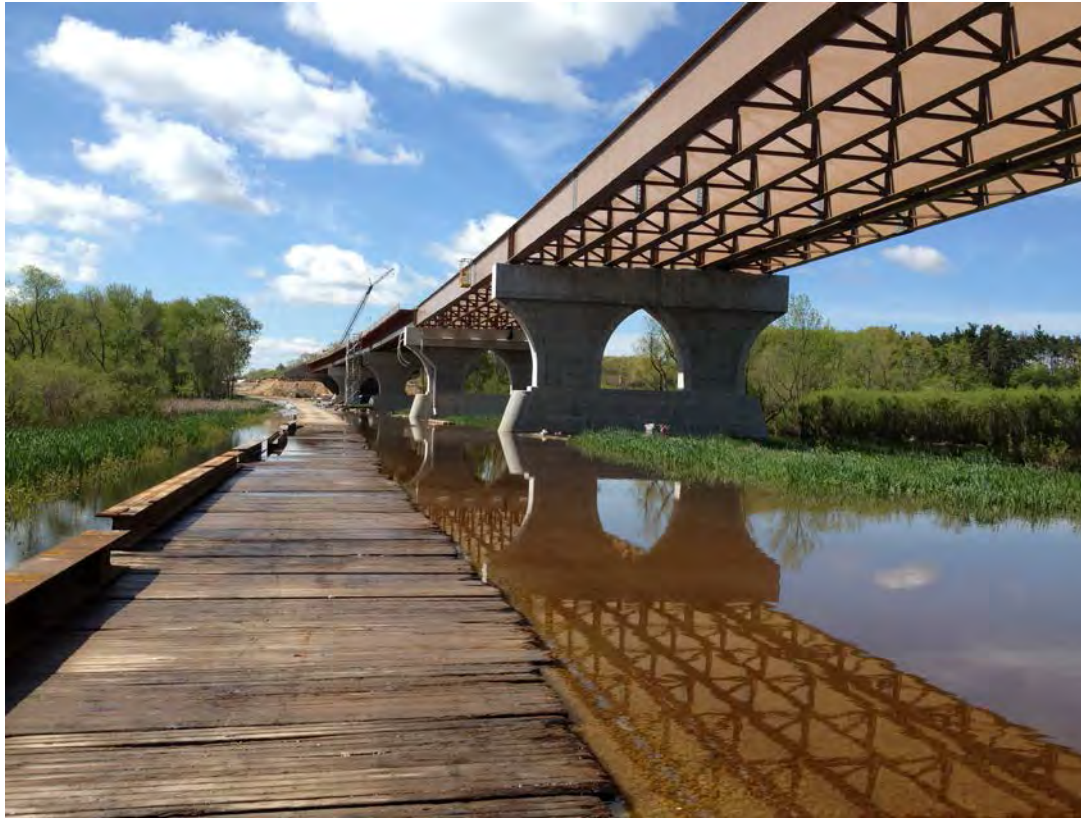
Temporary BMP – Elevated haul road in Conner Bayou

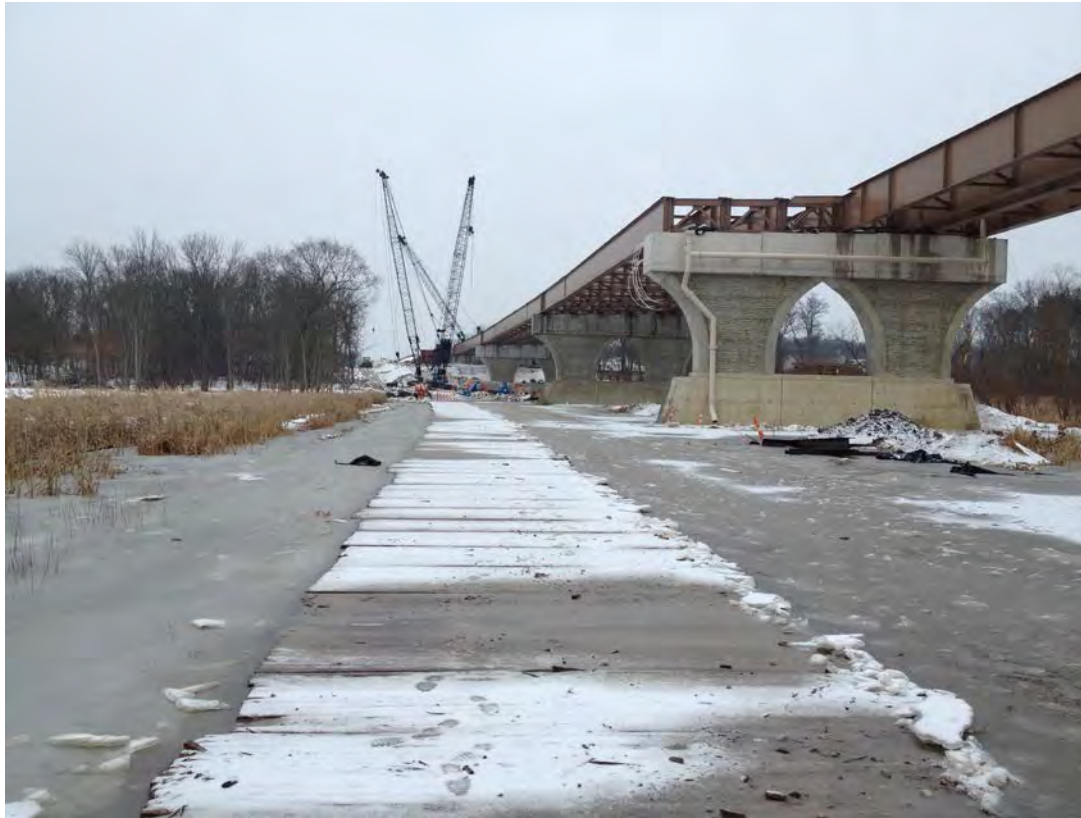
Haul route under winter conditions

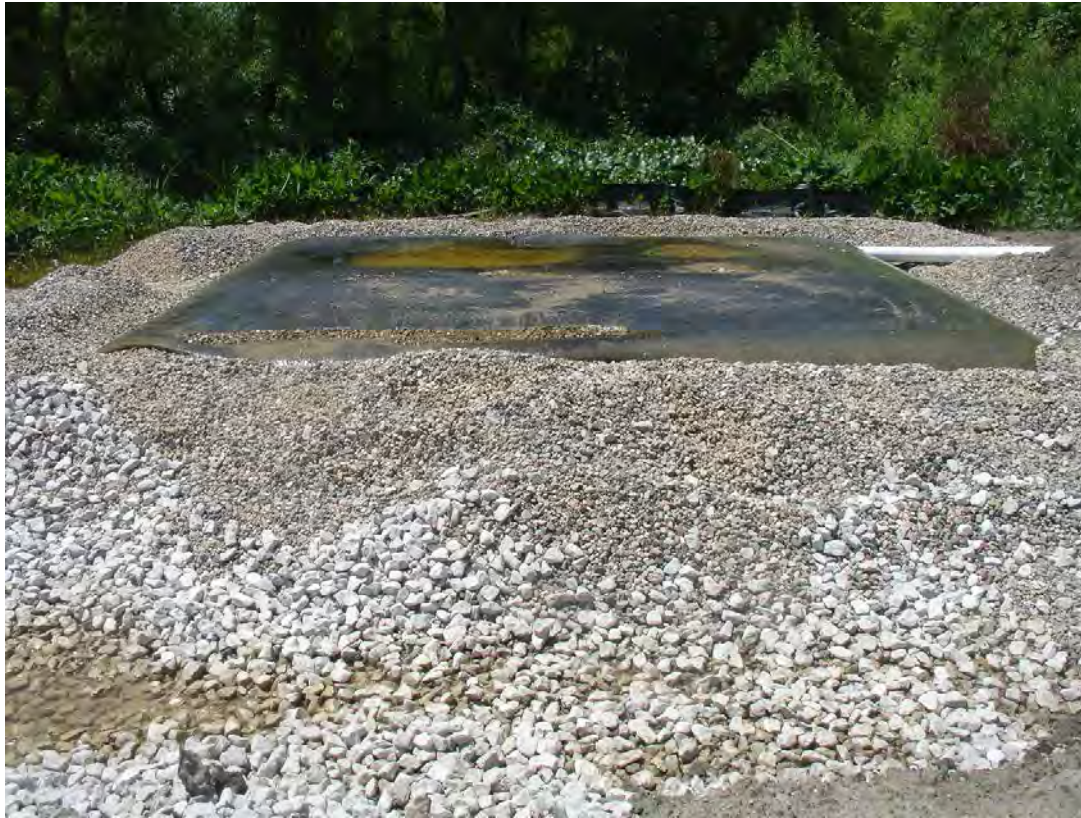
Temporary BMP – Dewatering through a filter bag atop washed aggregate

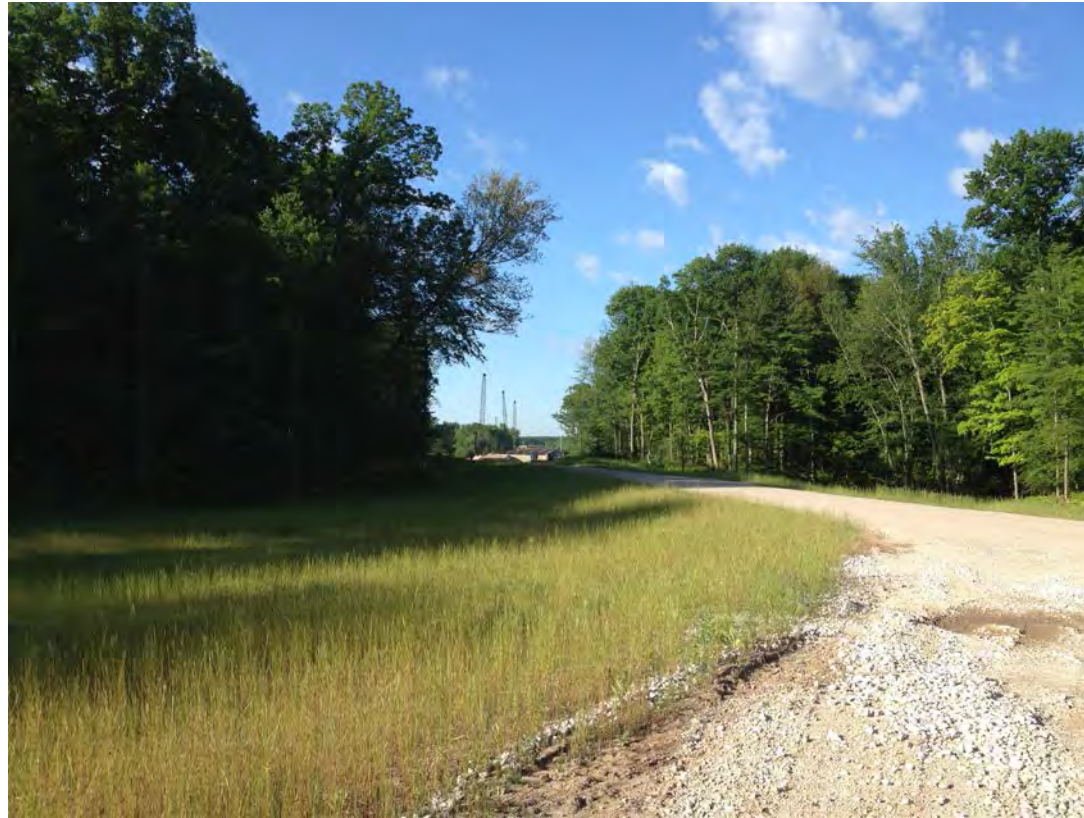
Temporary BMP - Temporary seeding of the road fill slope

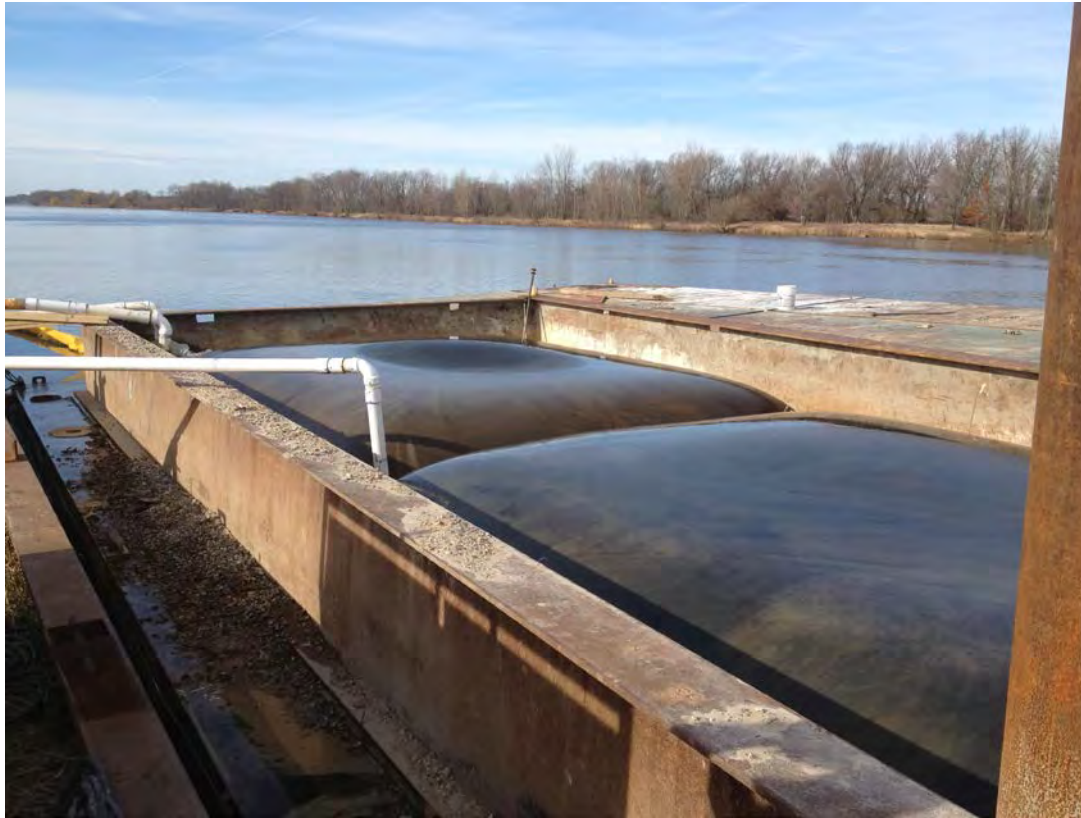
Temporary BMP – Dewatering through a filter bag over the Grand River

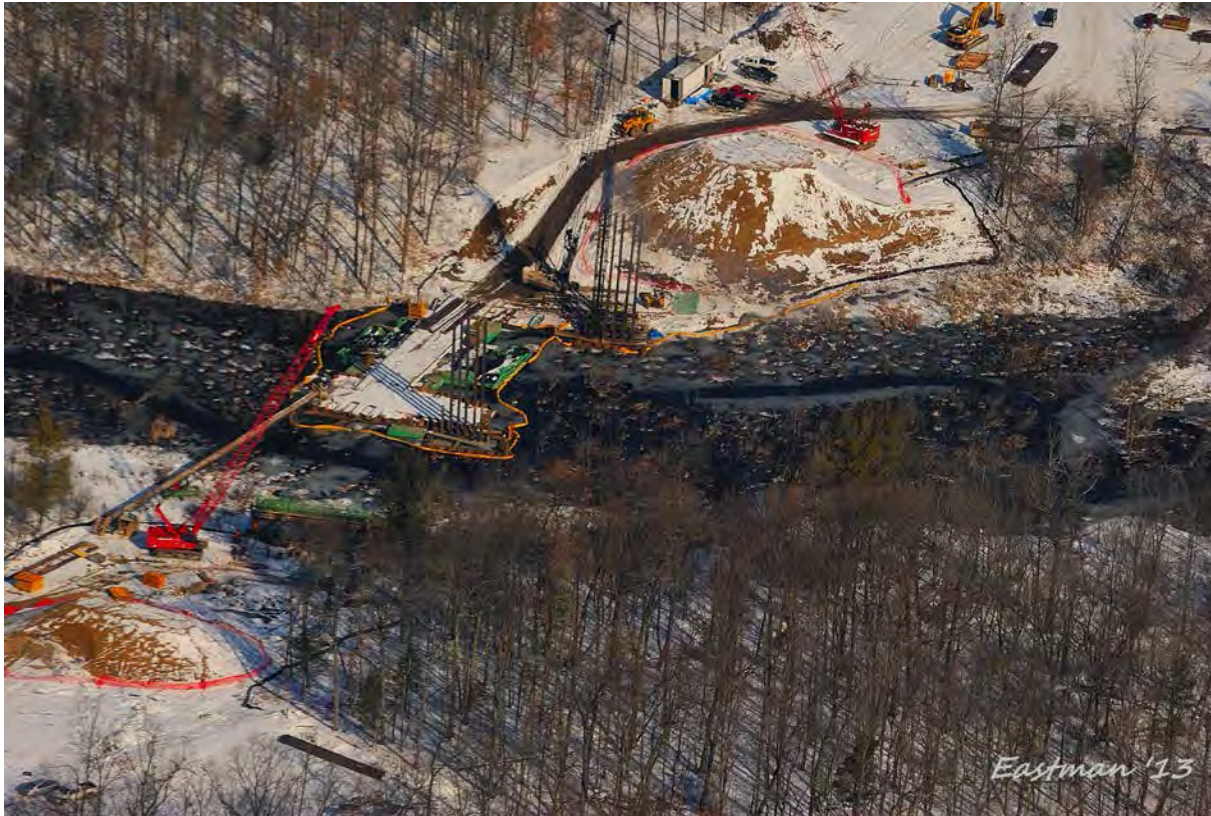
Temporary BMP – Turbidity curtain at Little Robinson Creek

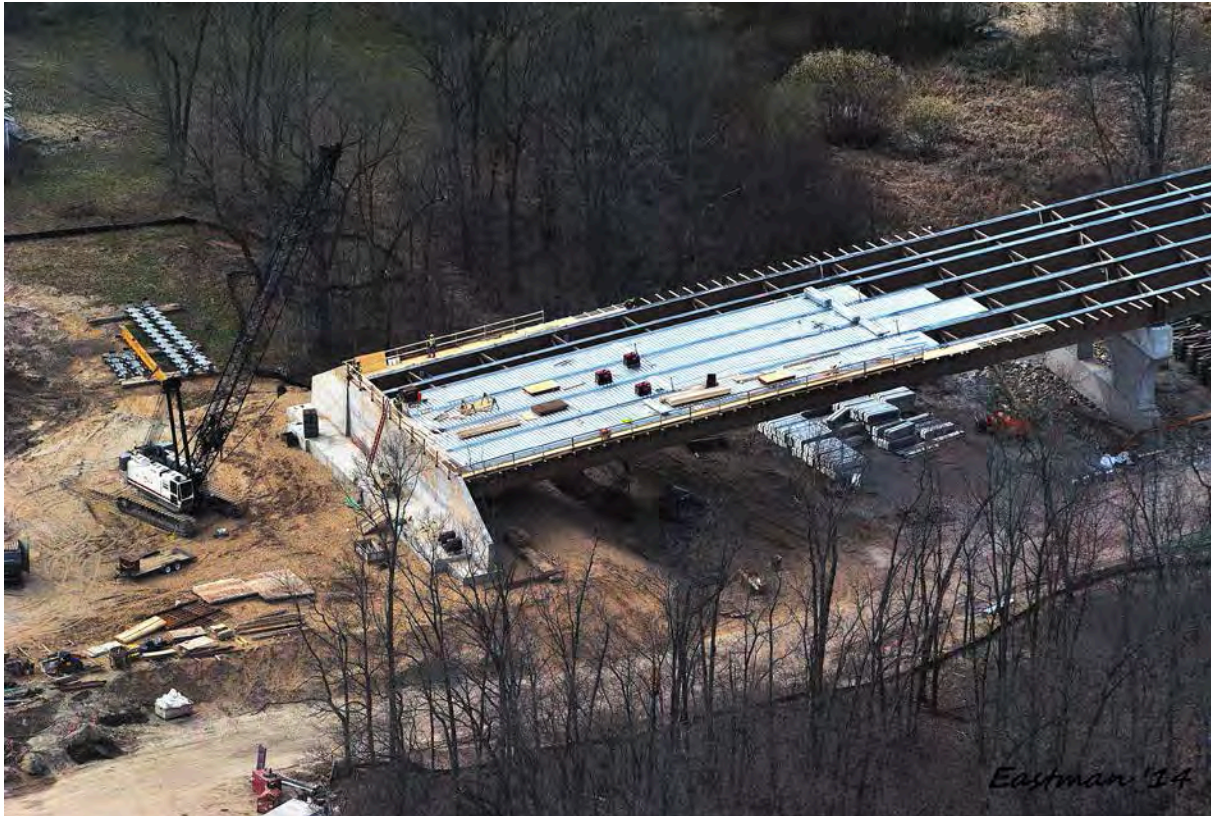
Temporary BMP – Silt fence near south abutment

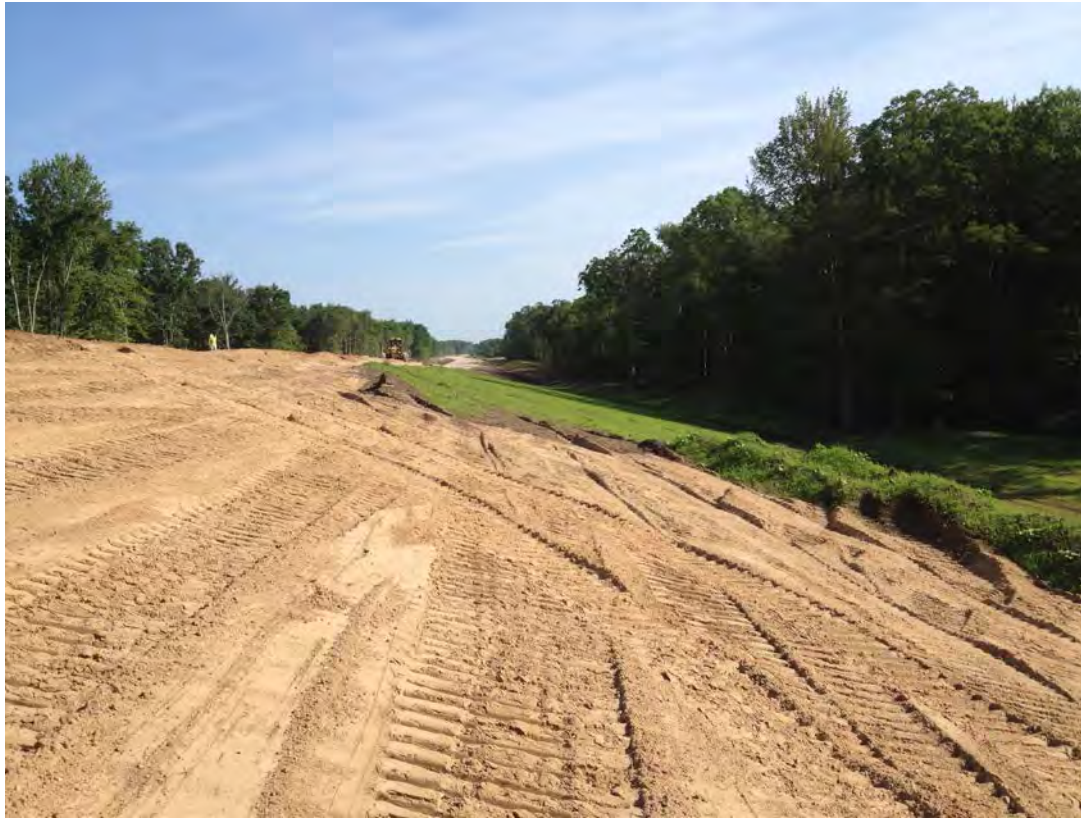
Temporary BMP – Temporary vegetation on areas not yet at final grade

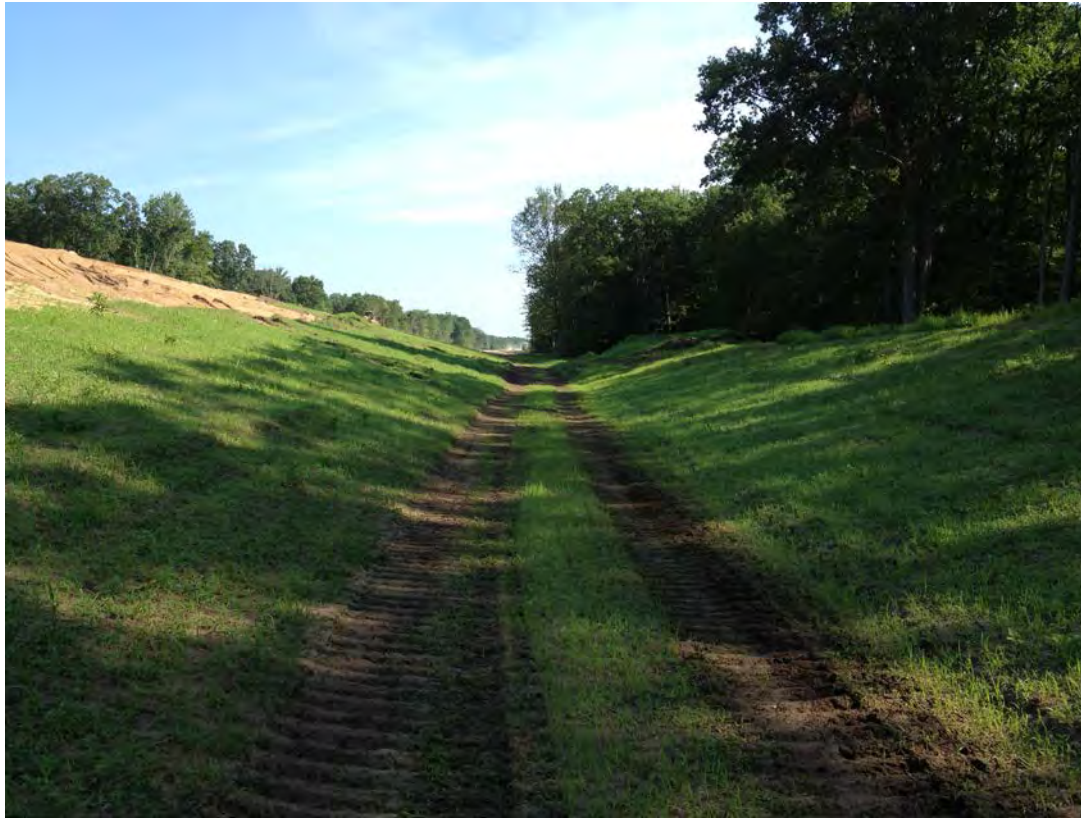
Temporary BMP – Vegetated road fill and back slope prior to attaining final grade

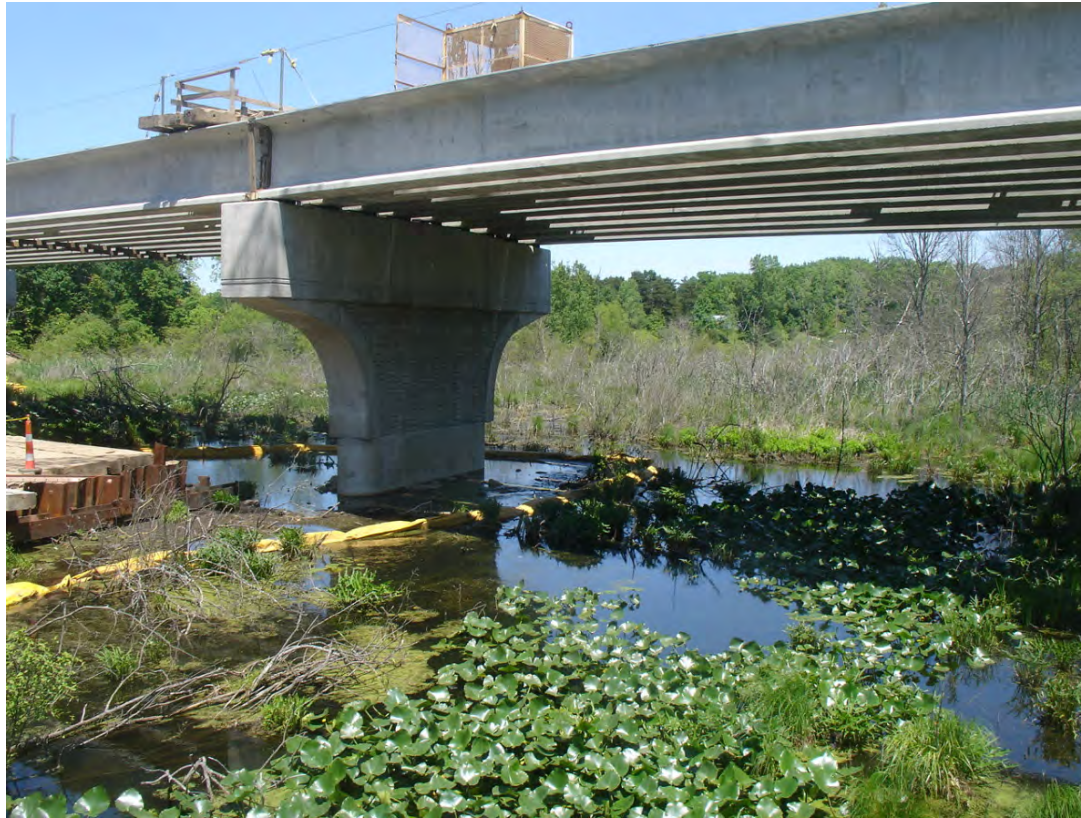
Temporary BMP - Turbidity curtain in wetlands at Little Robinson Creek

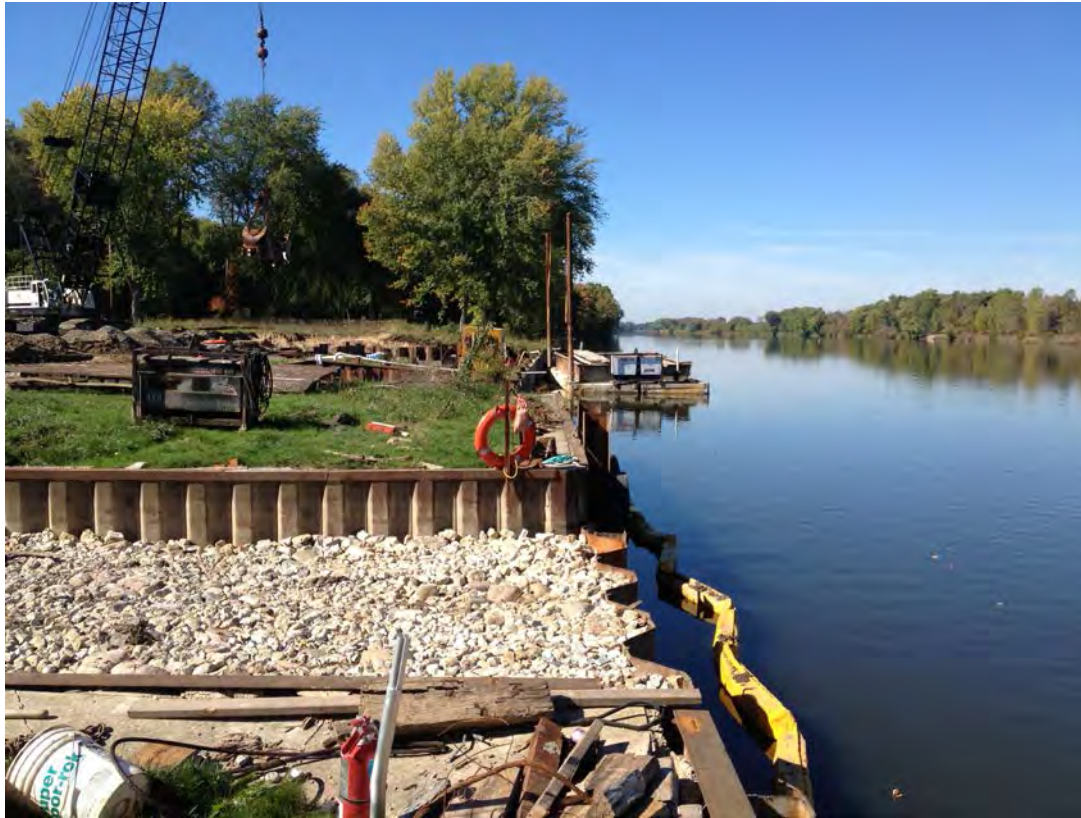
Temporary BMP – Turbidity curtain along the shoreline of the Grand River

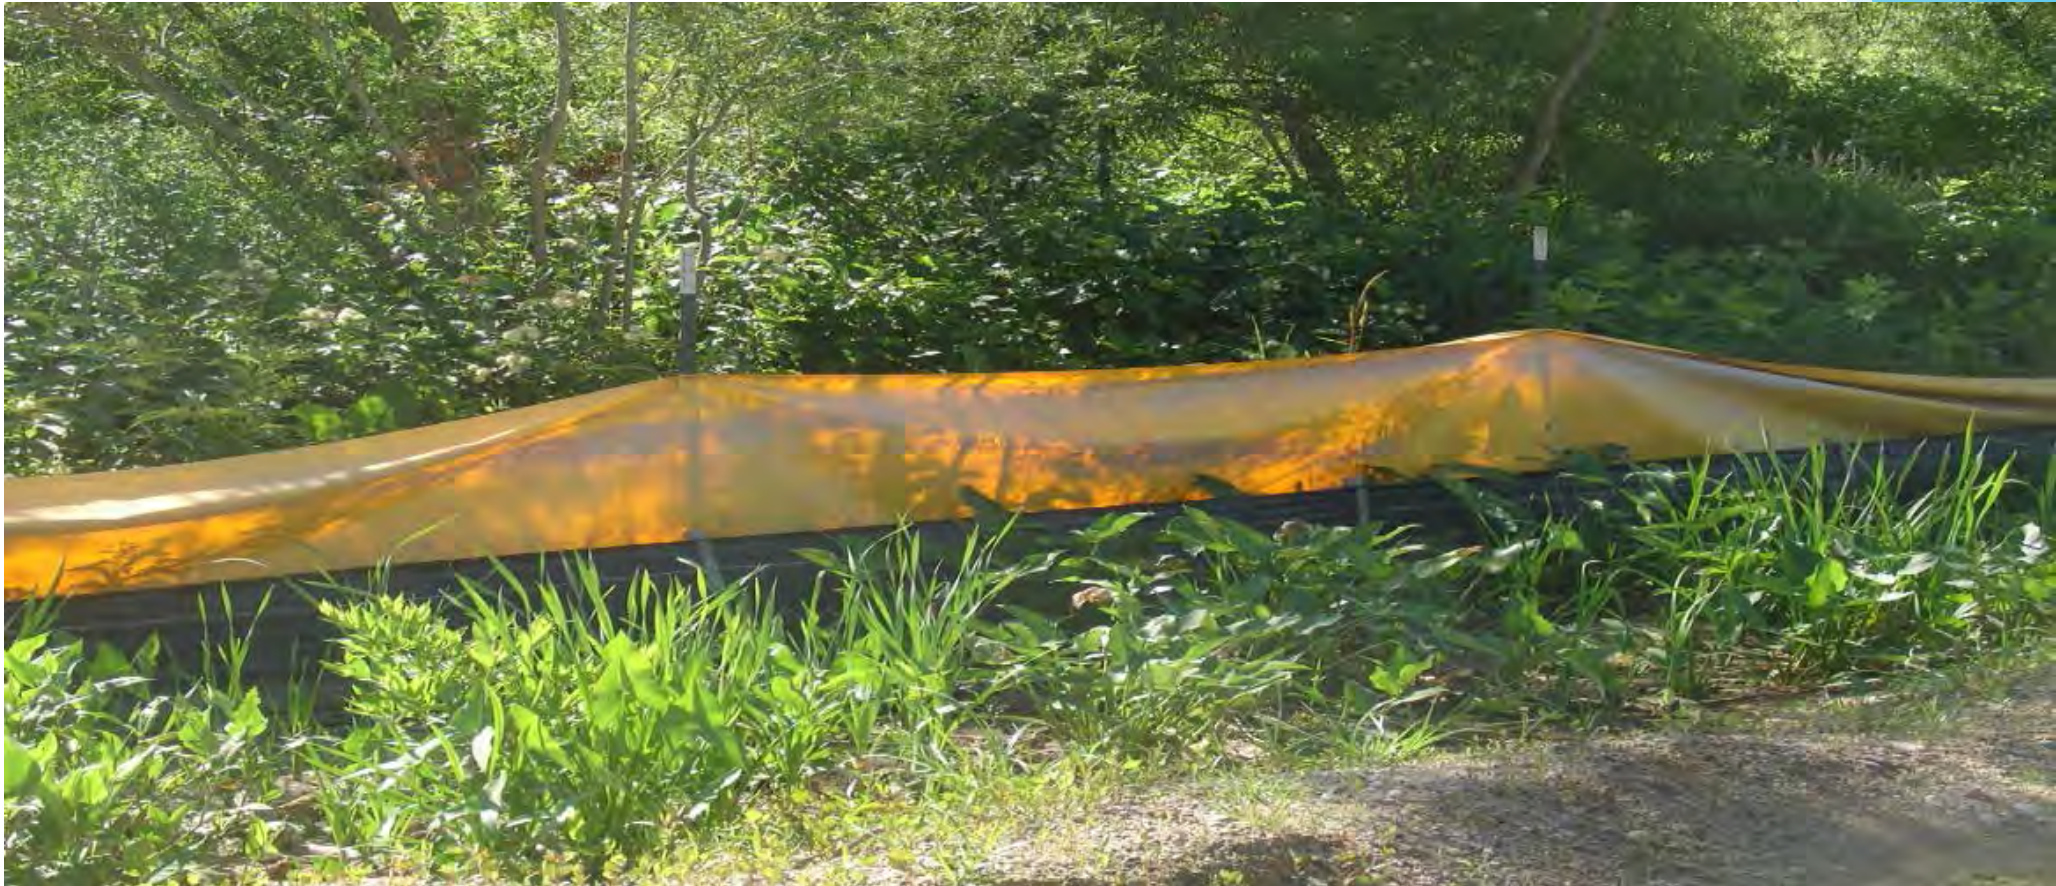
Temporary BMPs - Silt fence plus turbidity curtain

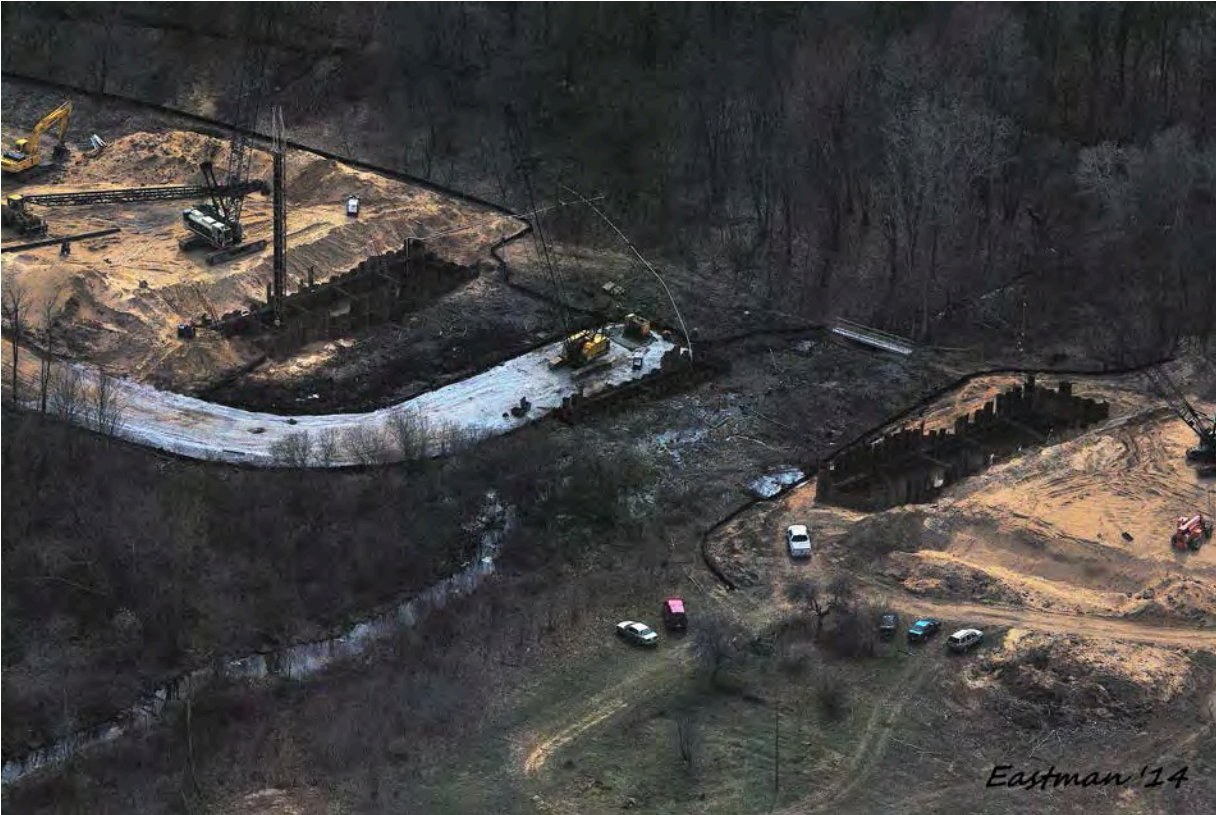
Temporary BMPs – Silt fence and temporary access road/pad at Stearns Creek
