M-231 and Water Quality

Ottawa County Water Quality Forum
November 21, 2016
James Fortney, MDOT

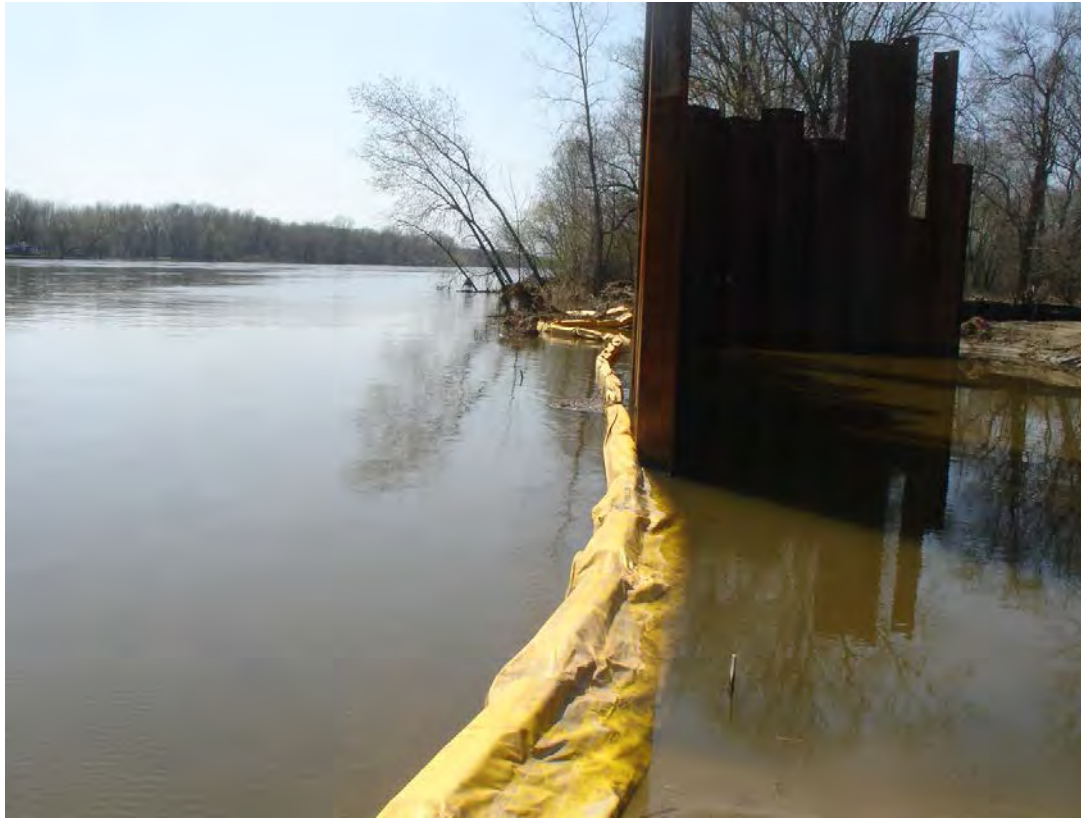
Temporary BMP – curtain in the Grand River at Pier 9

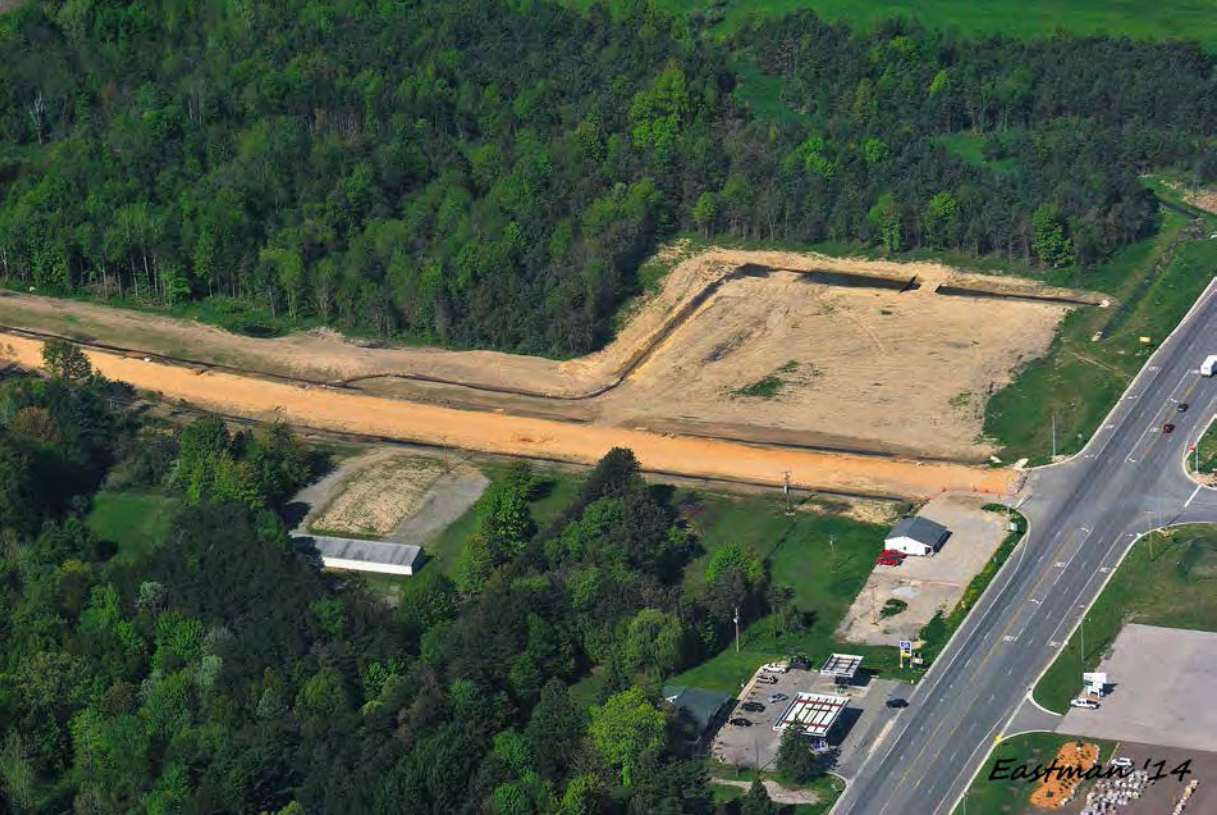
Permanent BMP – Storm water detention basin at M-104 (under construction)

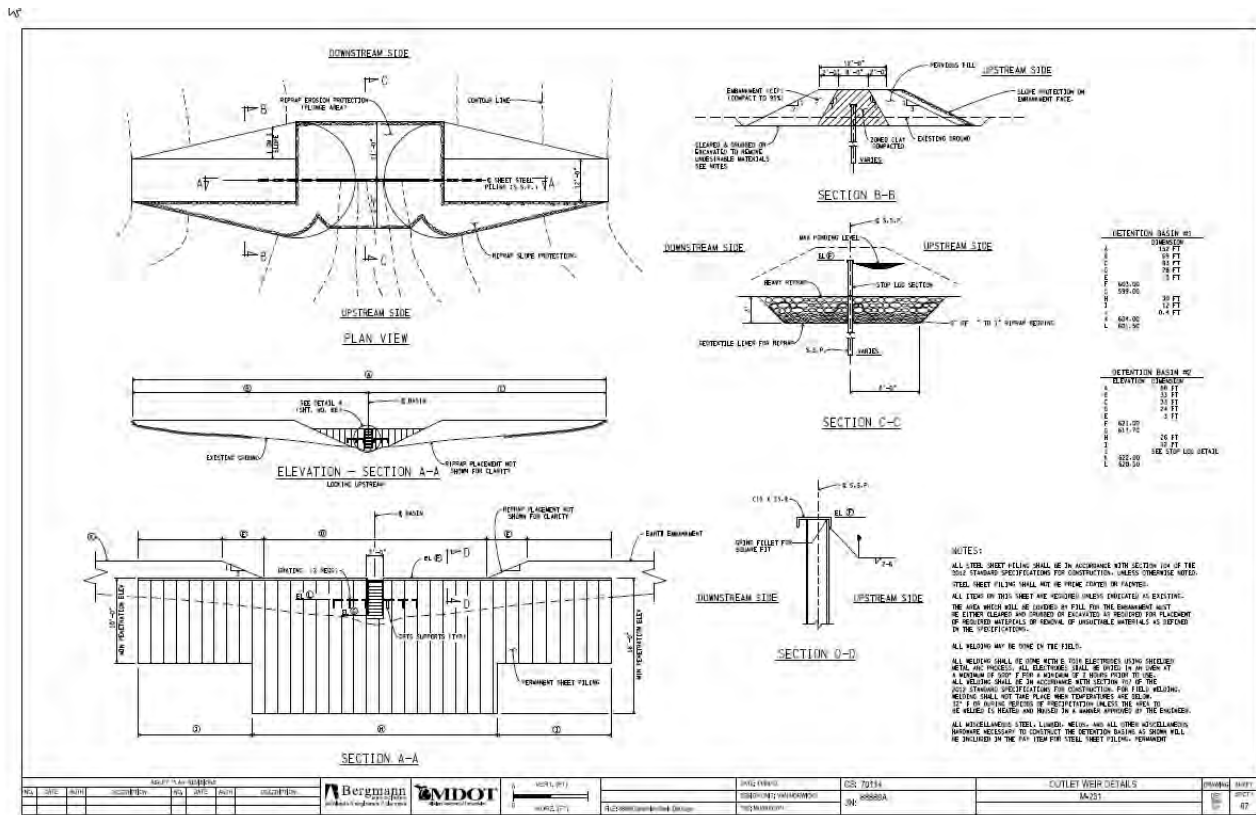
Permanent BMP – Controlled outlet from storm water basin at M-104

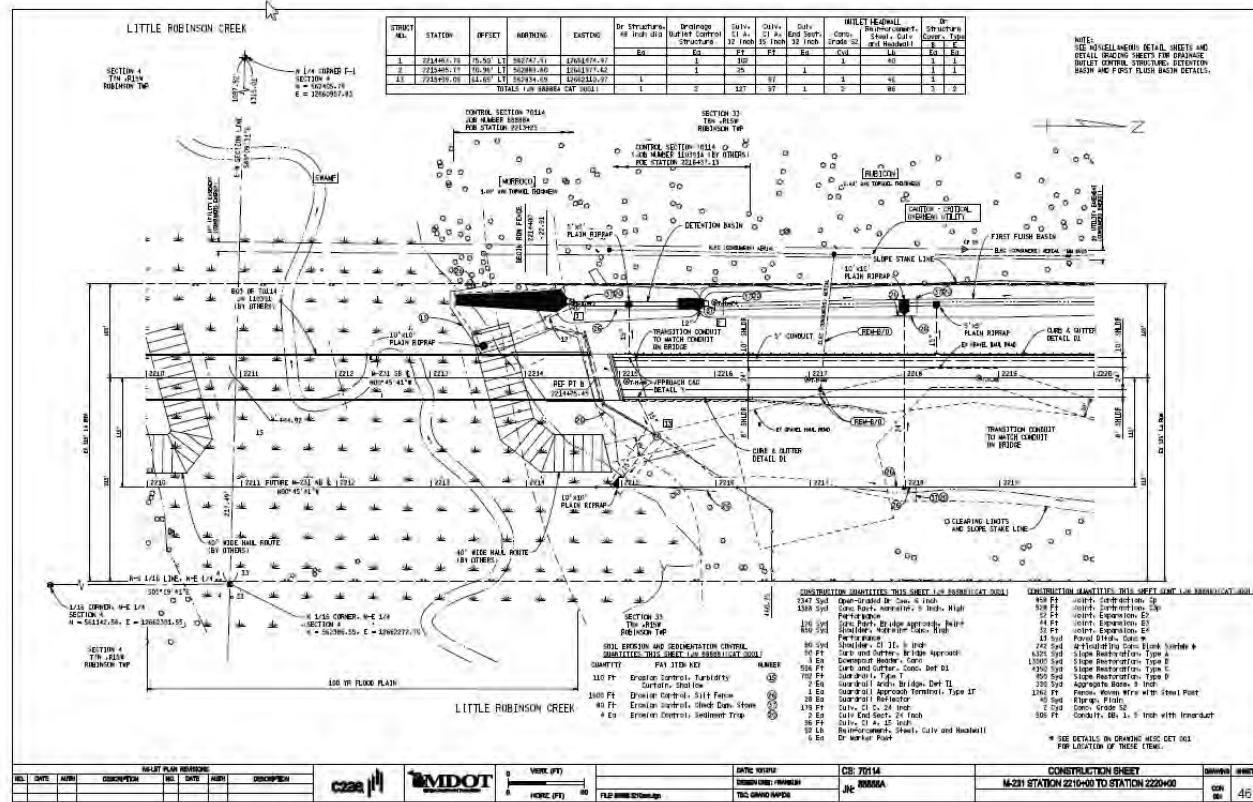
Permanent BMP – Linear storm water detention basin at Little Robinson Creek

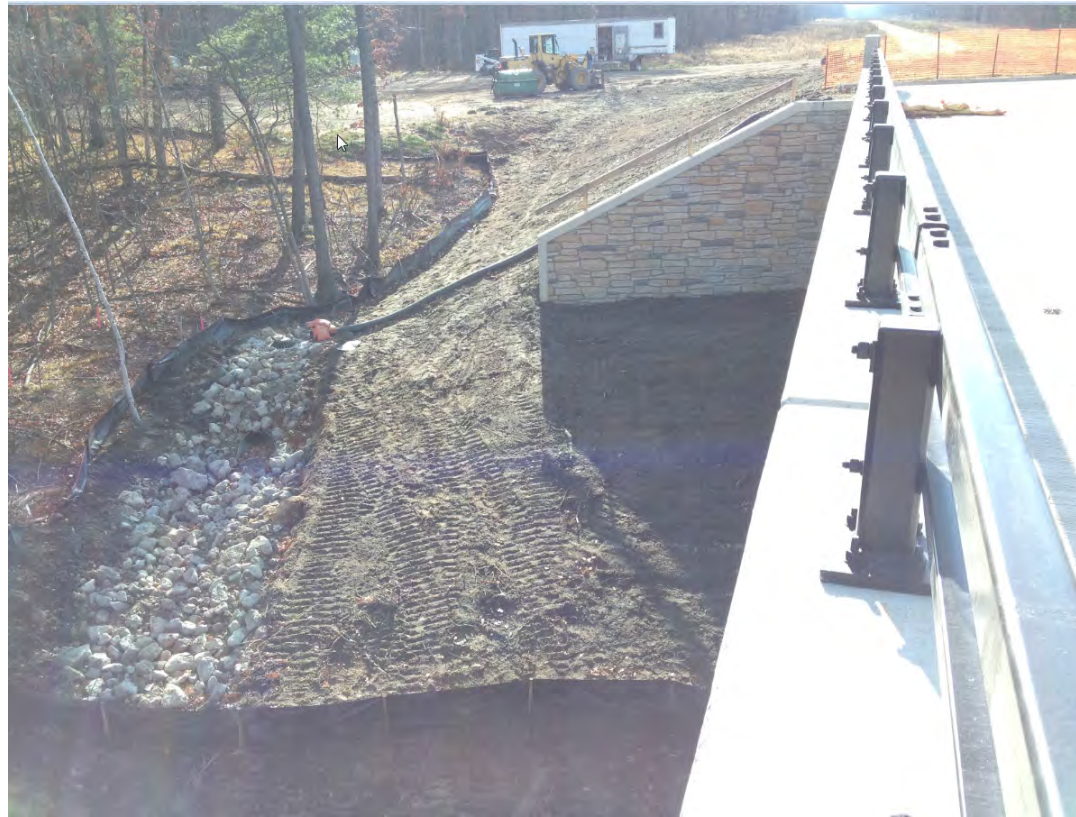
Permanent BMP – Storm water management at Little Robinson Creek.

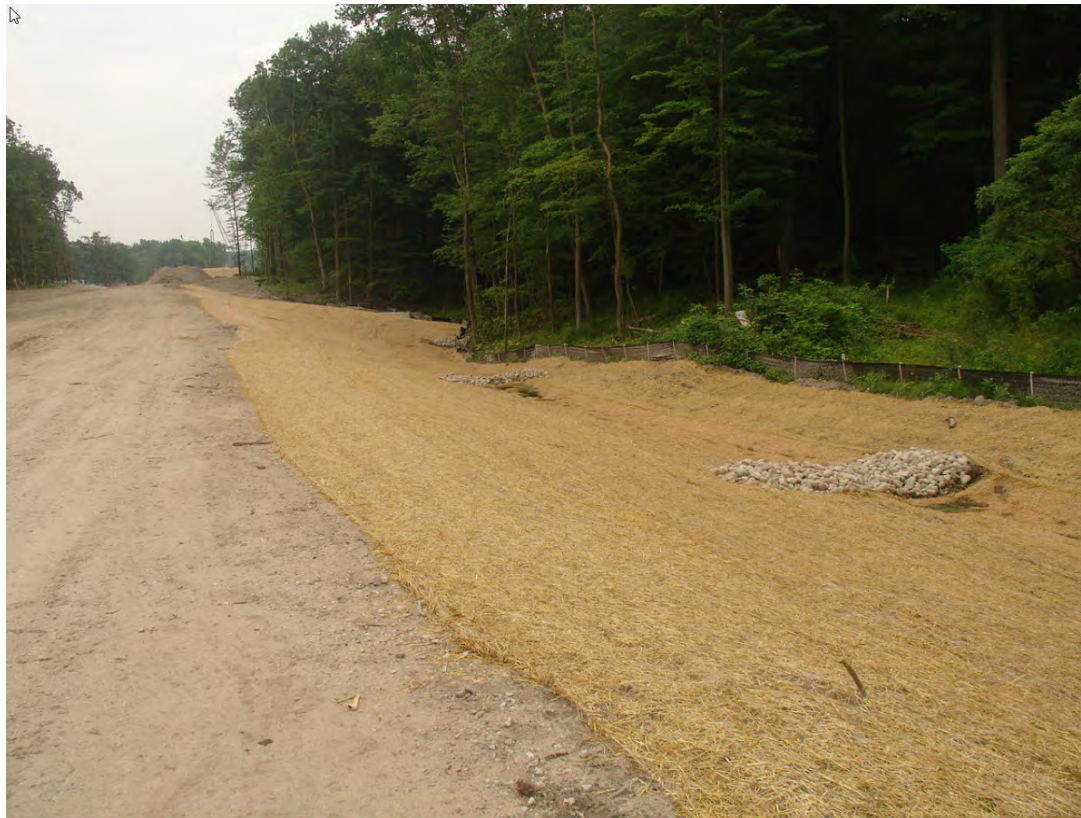
Permanent BMPs – Seed, mulch blanket, and check dams

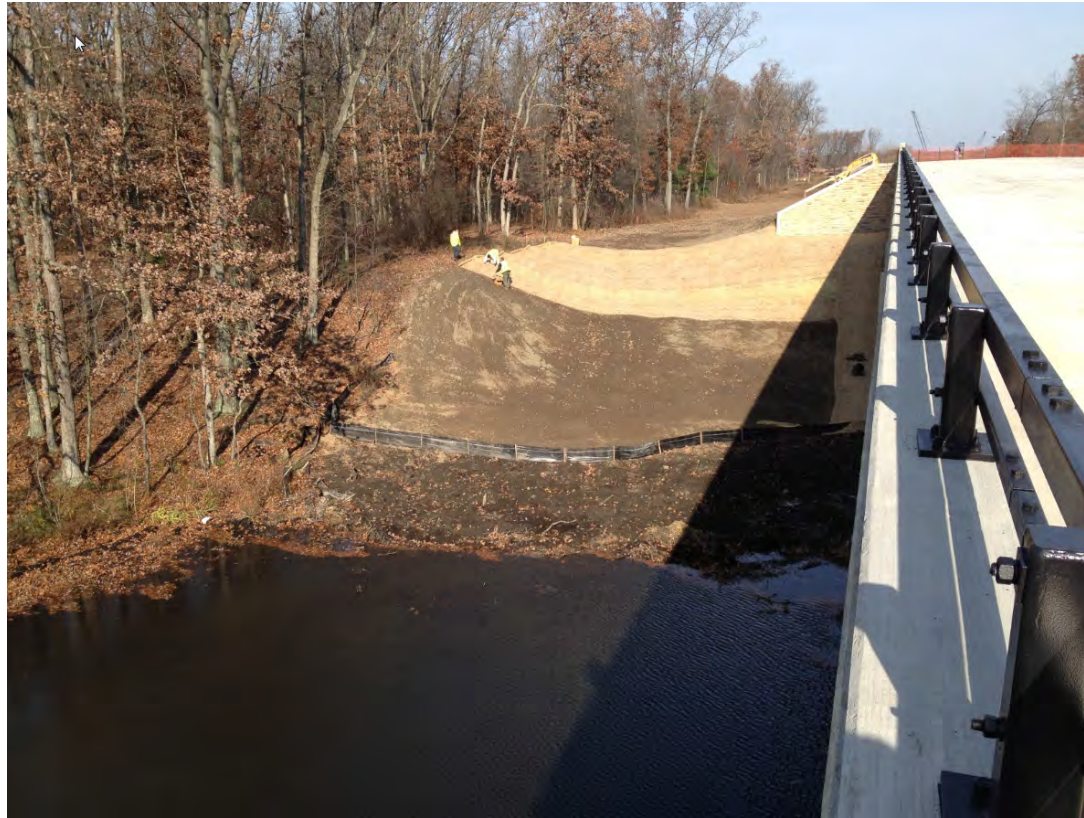
Permanent BMP – Seeding and Mulch Blanket at Little Robinson Creek

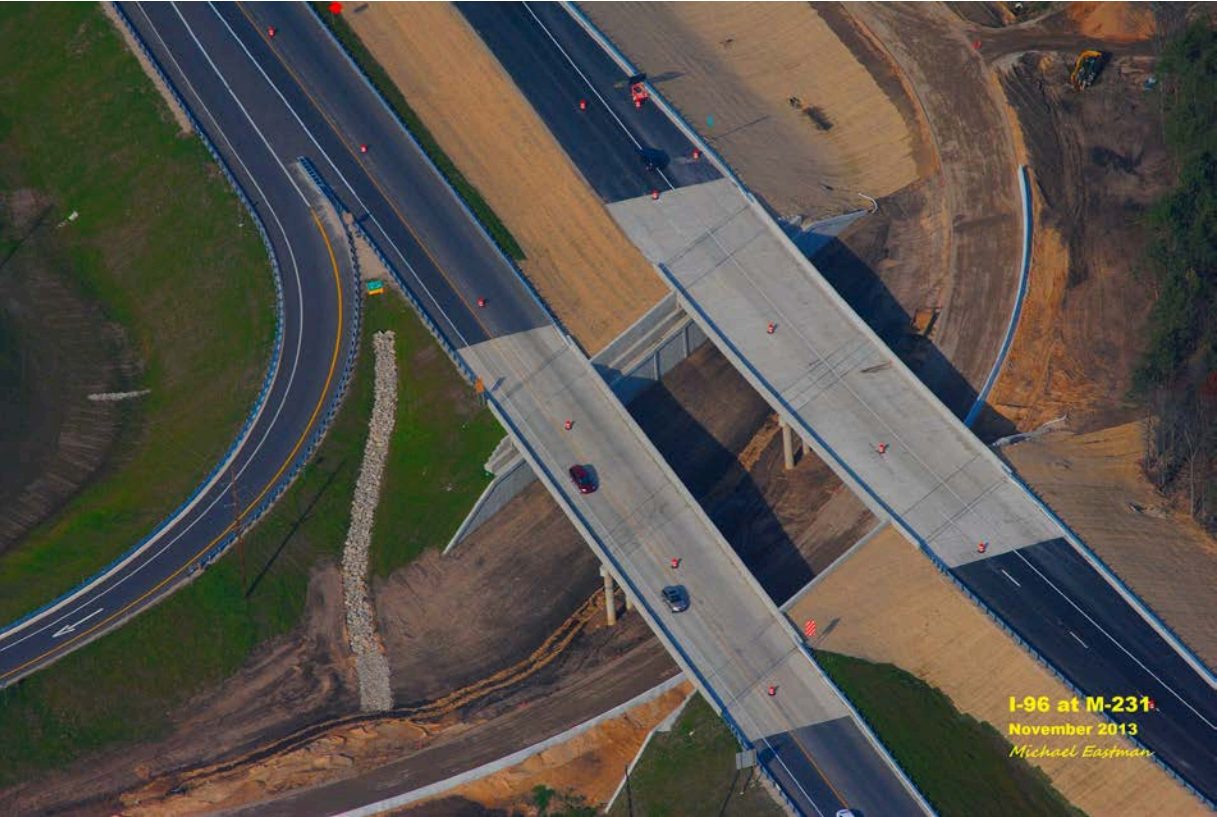
Permanent BMP - Riprap lined channel at I-96/M-231

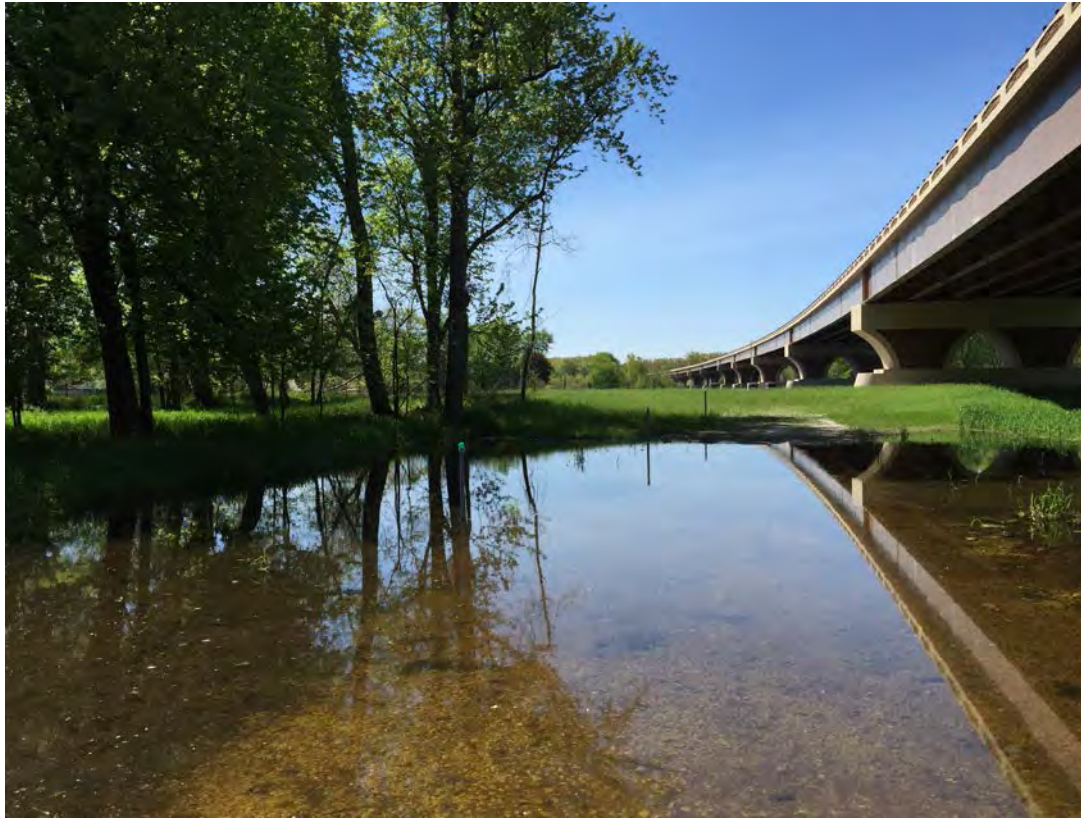
Permanent BMP – Vegetative Cover

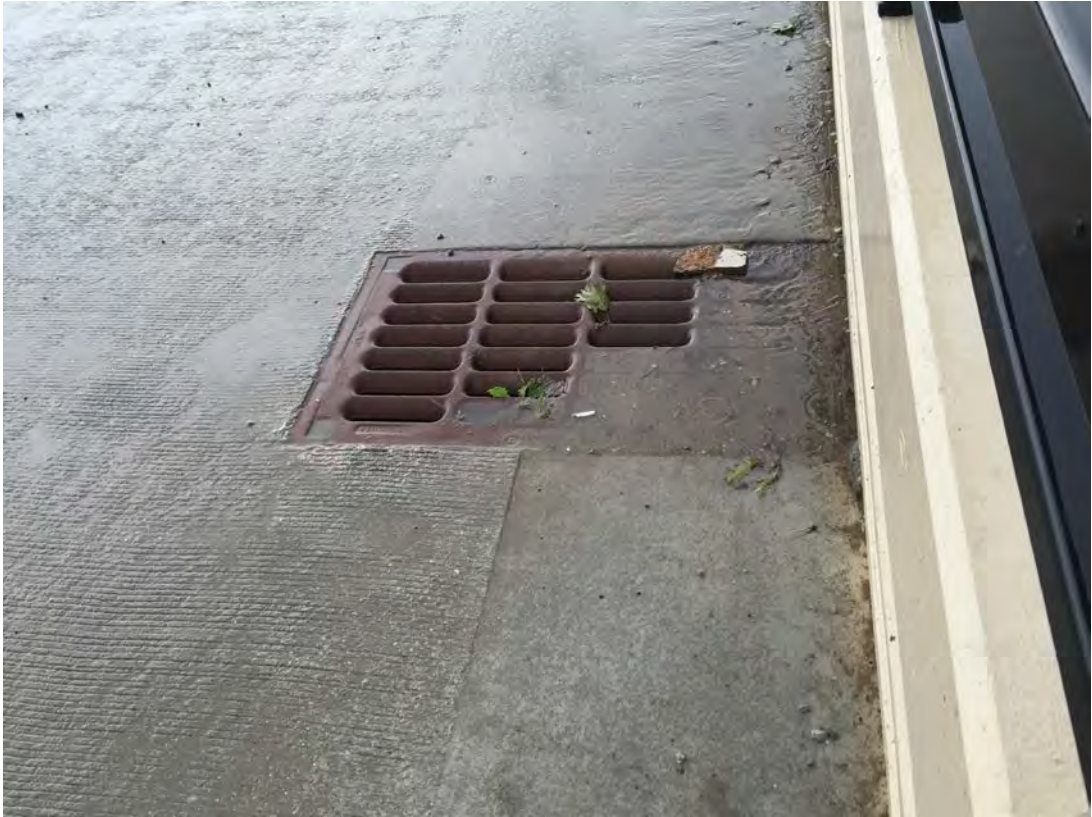
Deck drain on the bridge over the Grand River

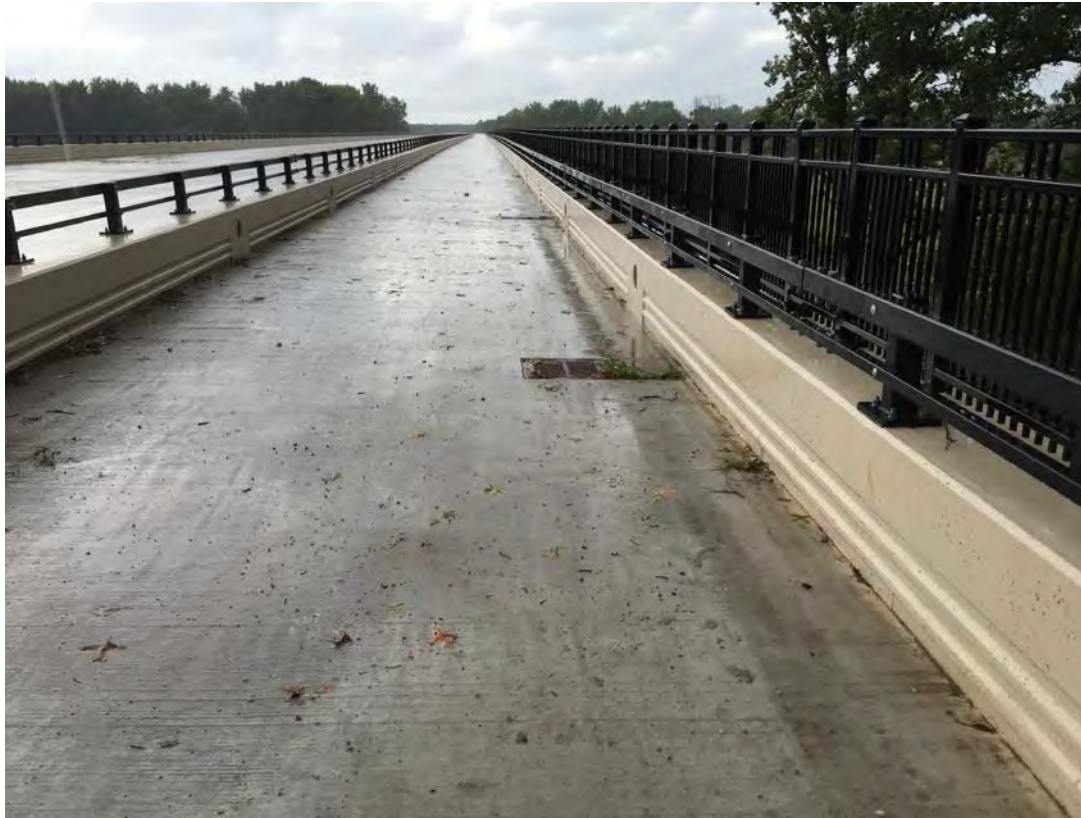
Deck drains on the multi-use lane

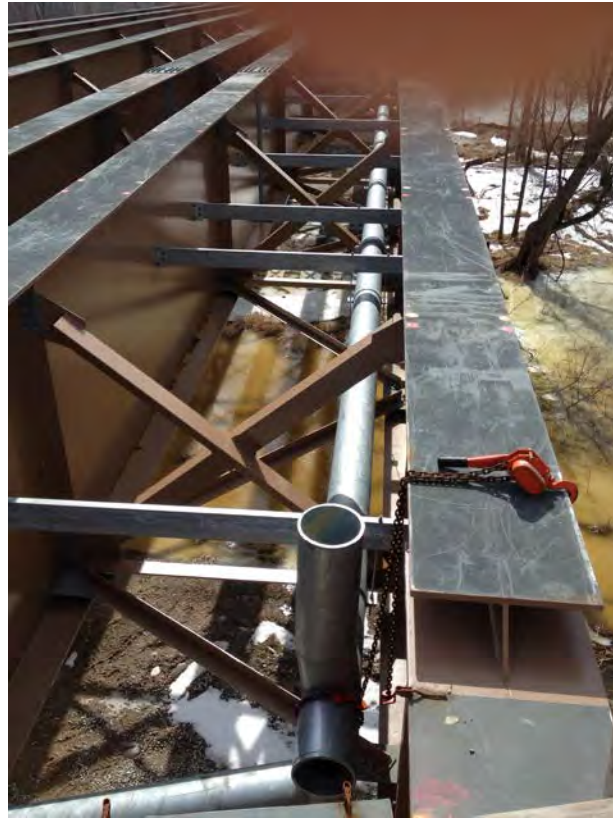
Storm water piping under the Grand River Bridge

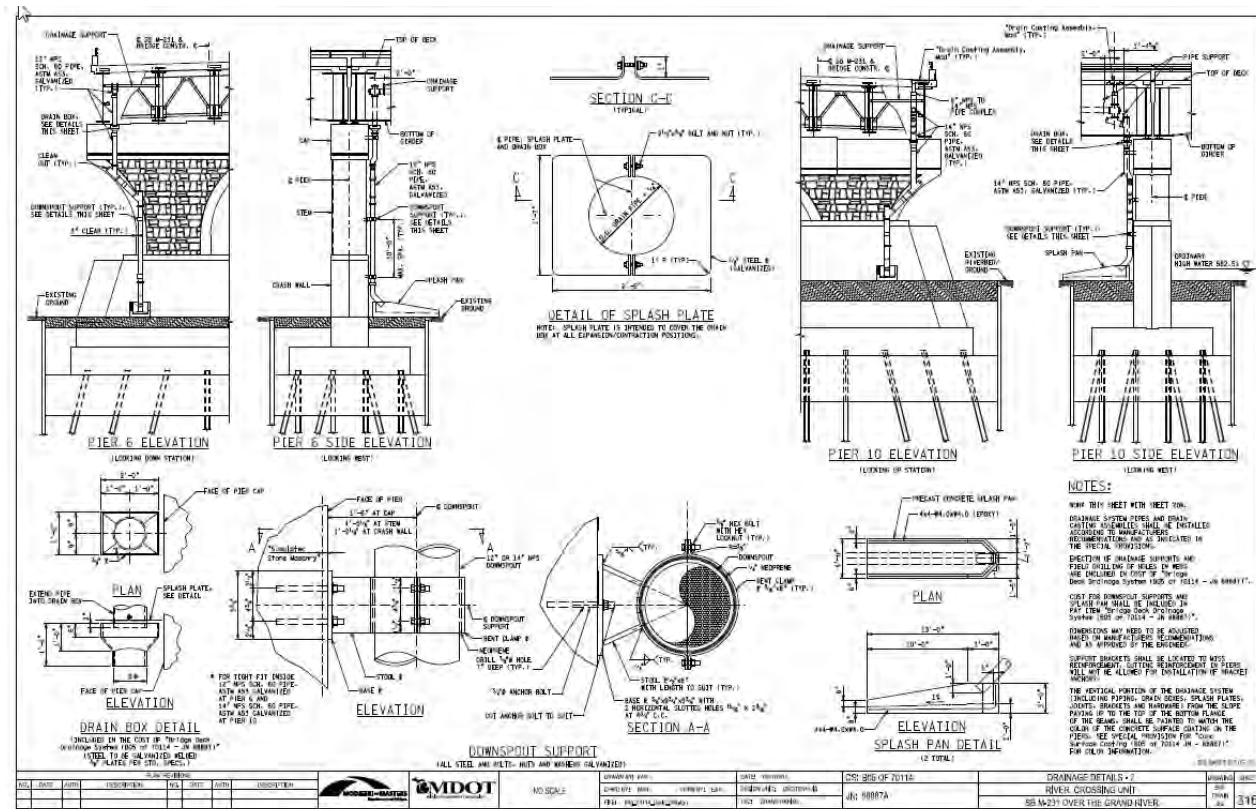
Permanent BMPs – Storm water Outfall Details

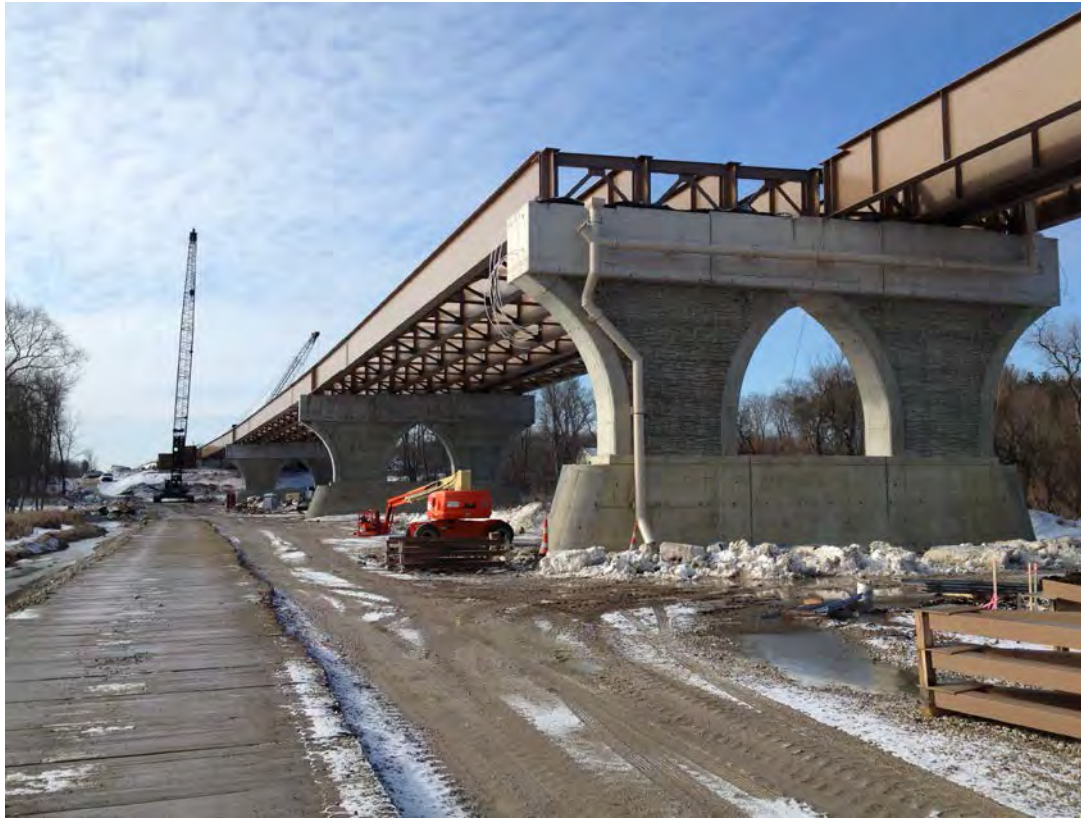
Permanent BMP - Storm water piping and outfall at Pier 3

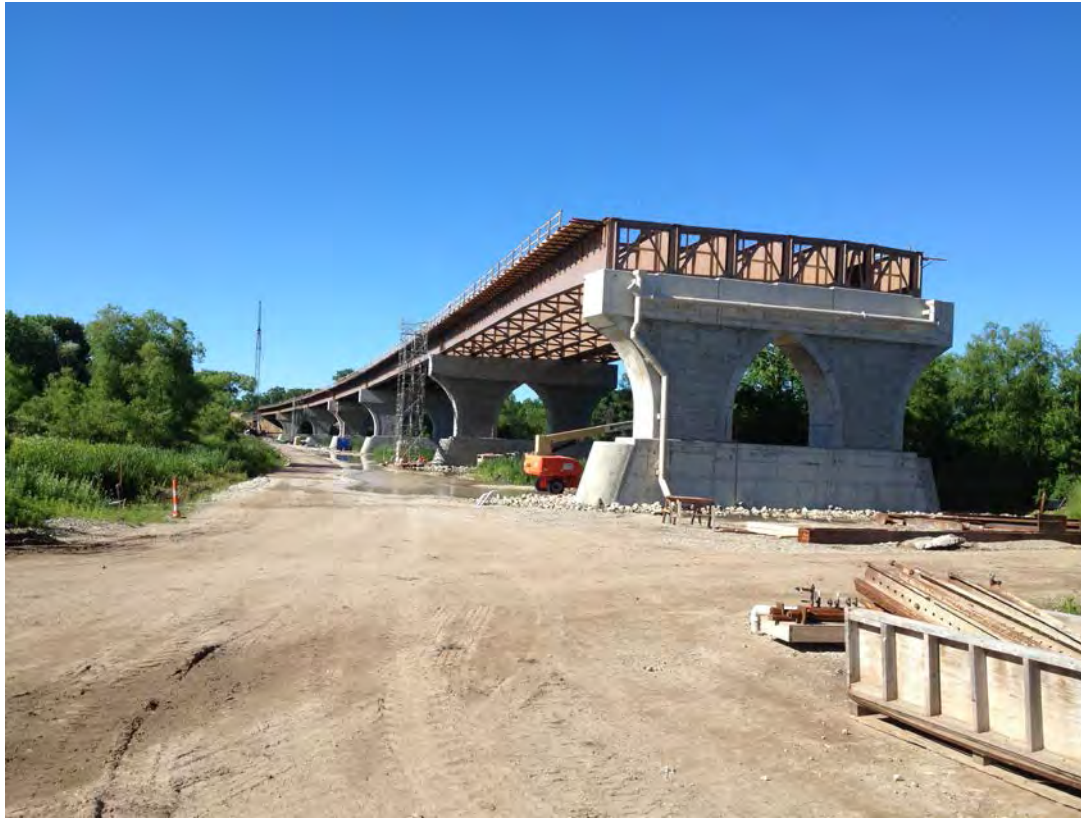
Permanent BMP - Storm water piping and outfall at Pier 6

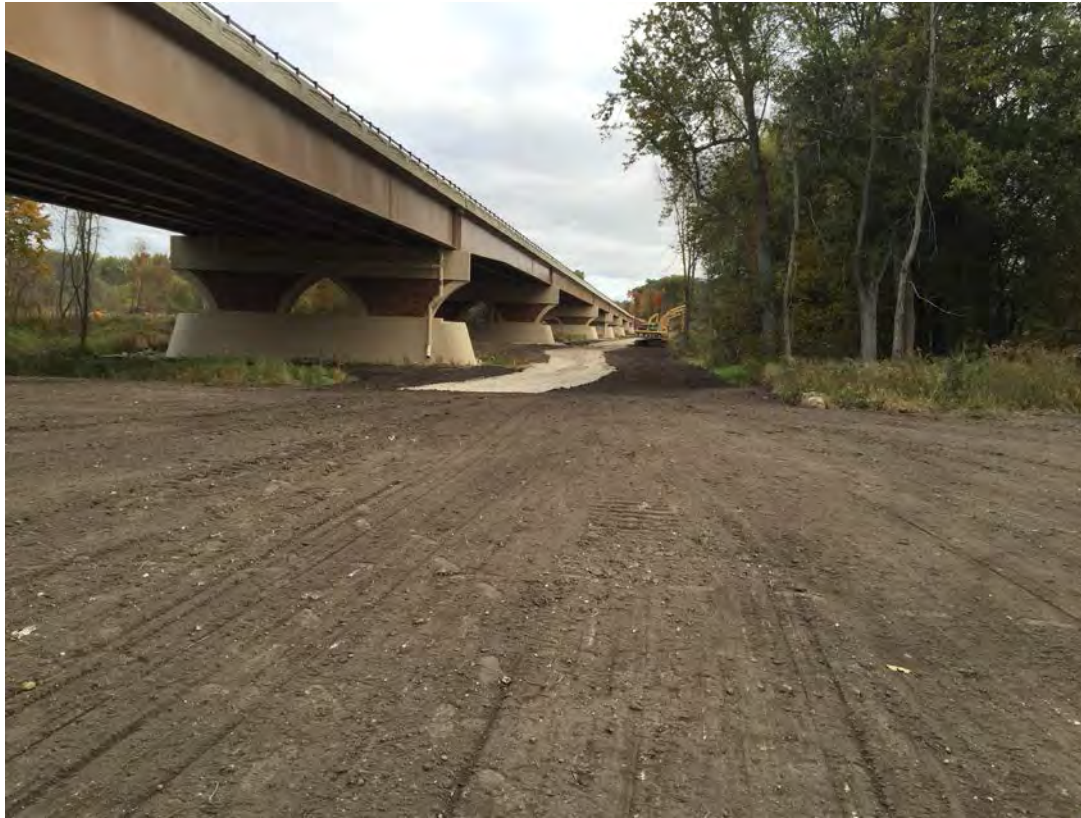
Permanent BMP – Storm water Outfall at Pier 10

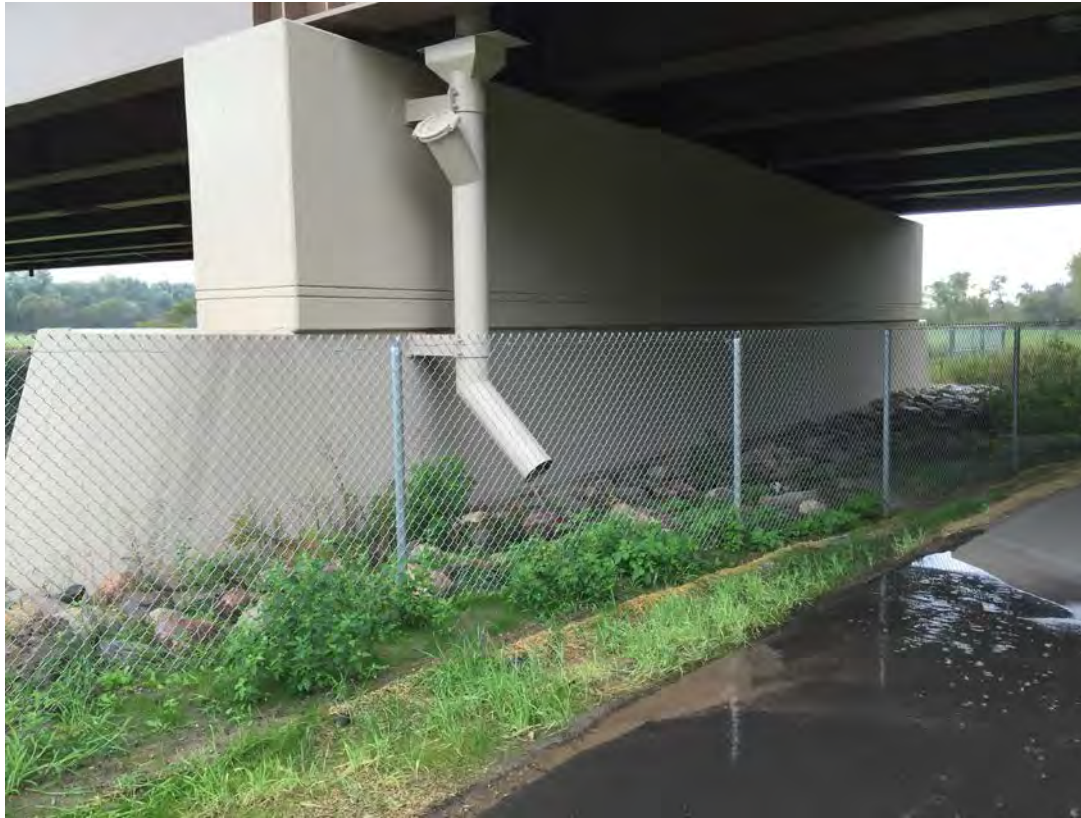
Permanent BMP - Storm water outfall at Pier 15

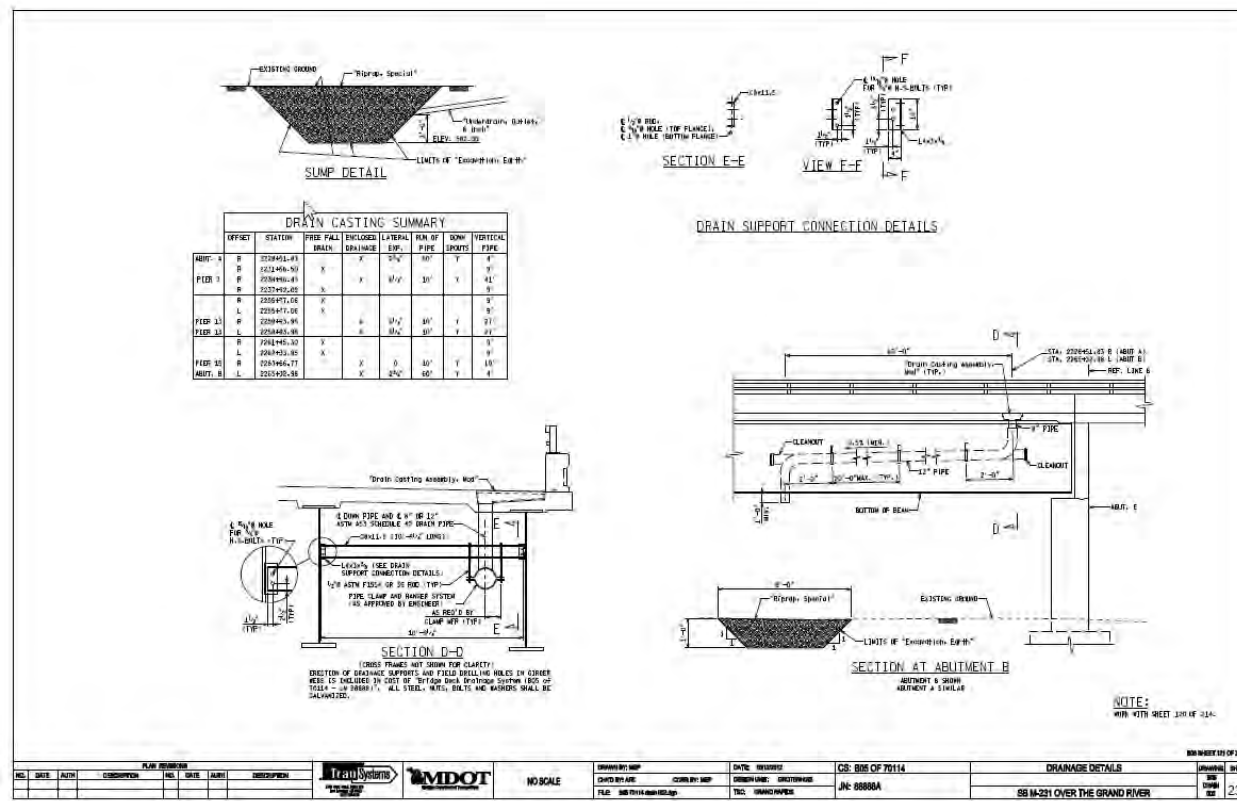
Permanent BMP – Scupper Pad Detail

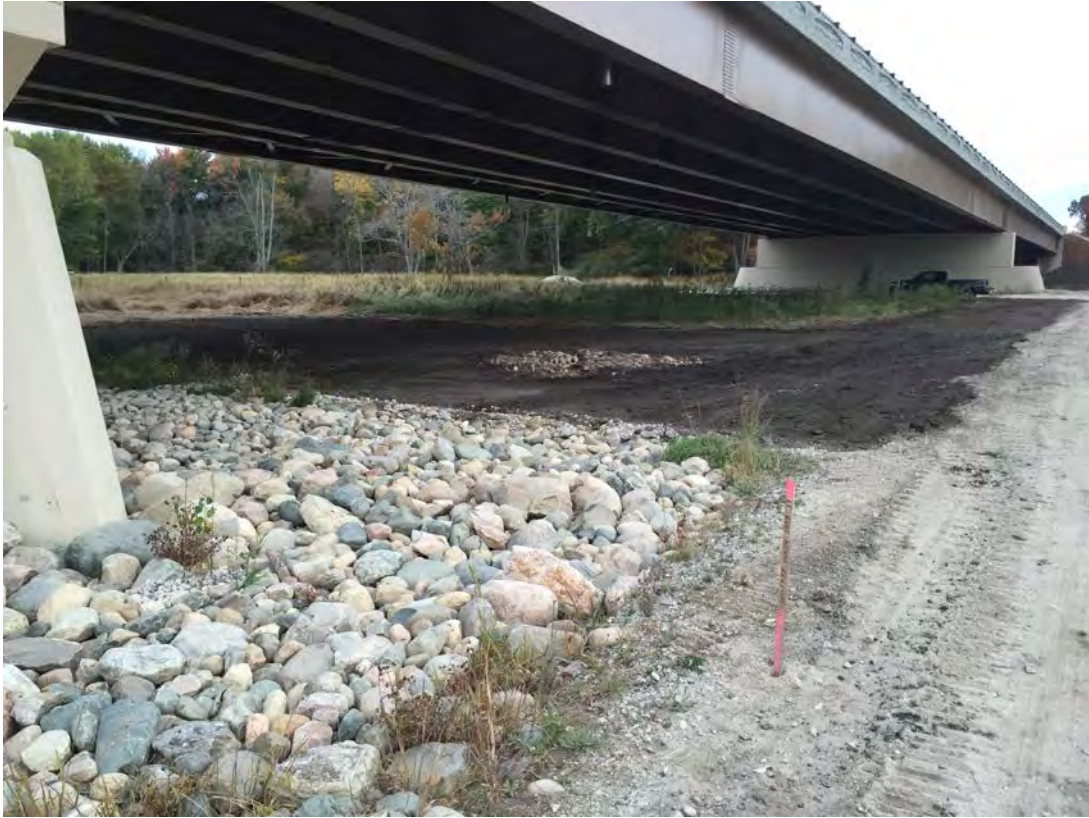
Permanent BMP - Scupper and pad at Pier 13

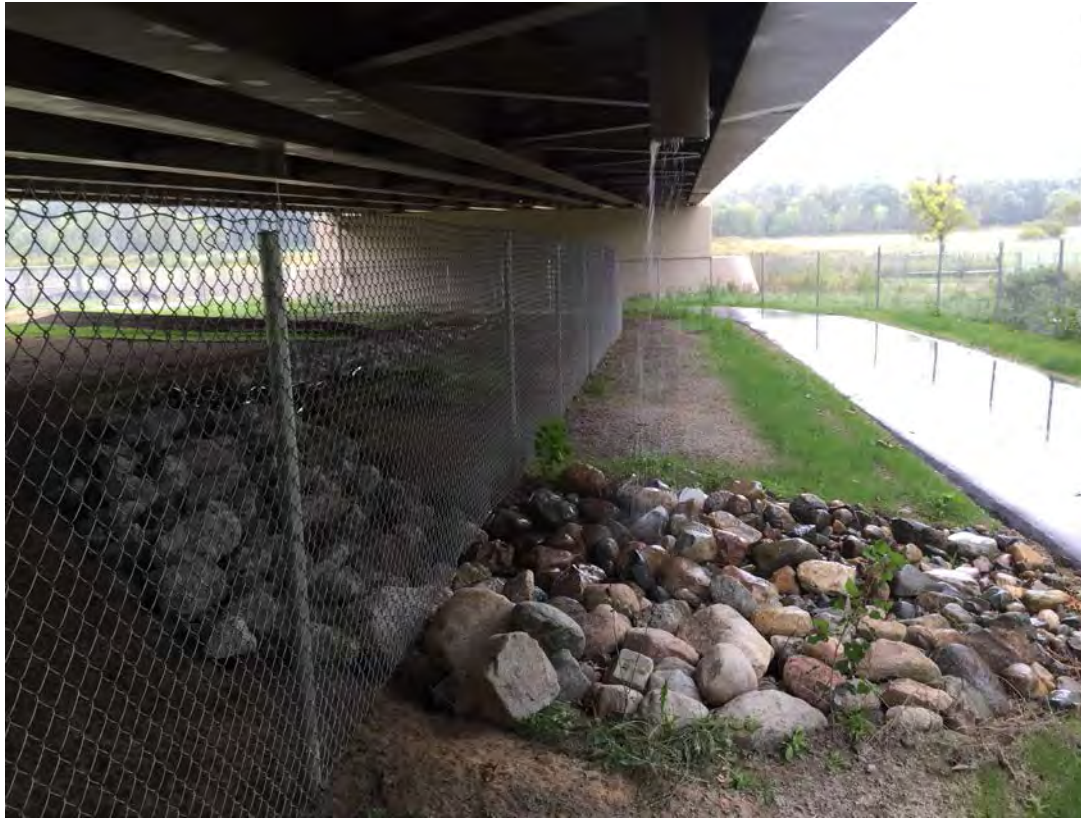
Permanent BMPs – Riprap pad beneath scupper

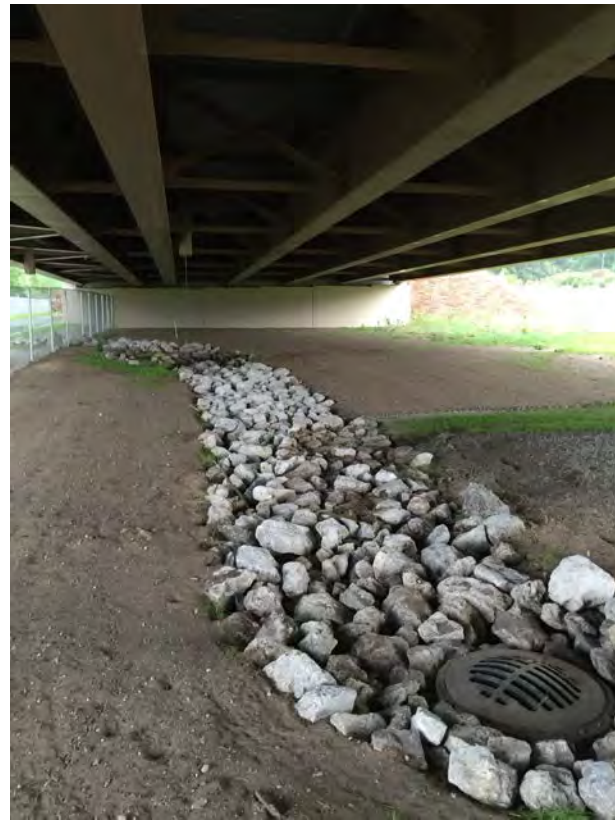
Permanent BMPs– Riprap channel between scupper pad and storm sewer (with sediment sump)

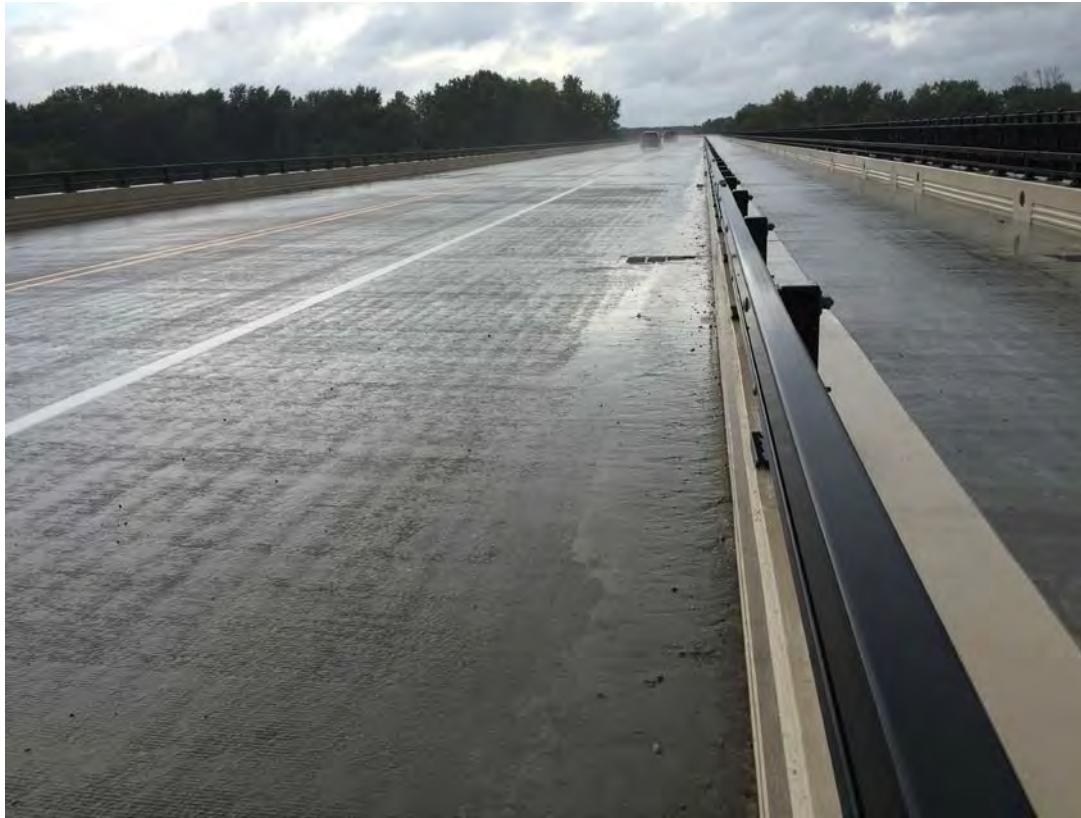
Storm water running in the gutter within the road shoulder

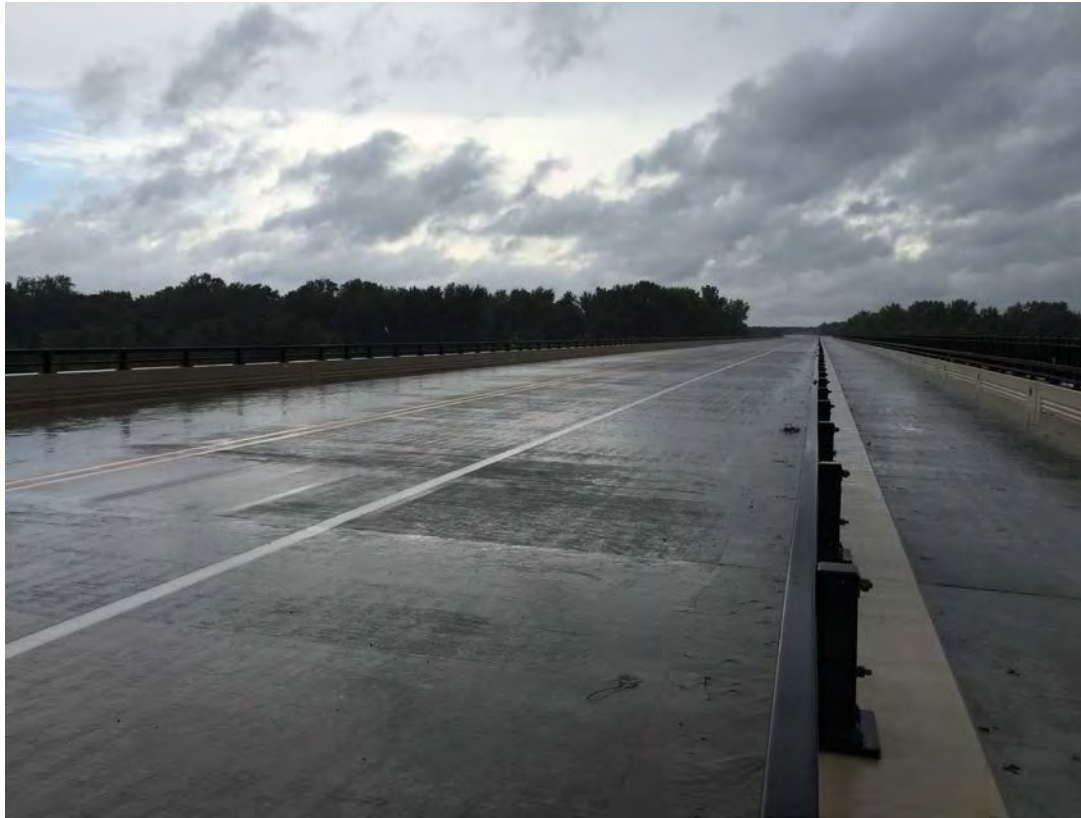
No standing water in the travel lanes.
